CASE STUDY 4

Beavers living in and around a water-supply reservoir

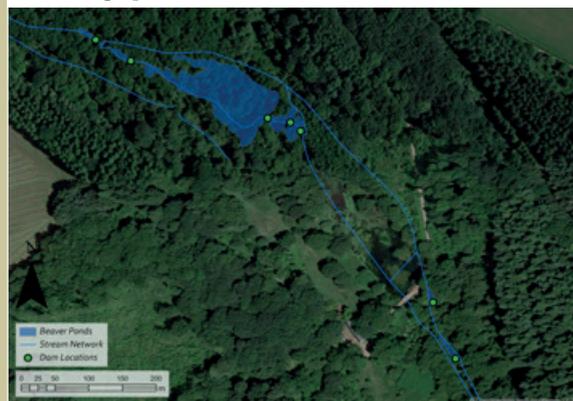
Extent of open water created by beavers as a result of damming upstream of Otterhead Lakes.

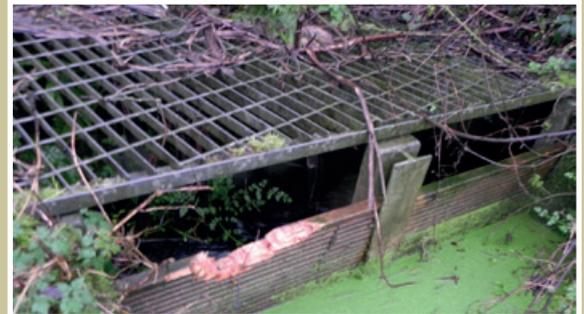
The crest of a spillway within a culvert has been the focus of damming activity by beavers. The ROBT was supported by local volunteers who inspect and remove the build-up of beaver sticks.
