CASE STUDY 5

Release of beavers into a County Wildlife Site

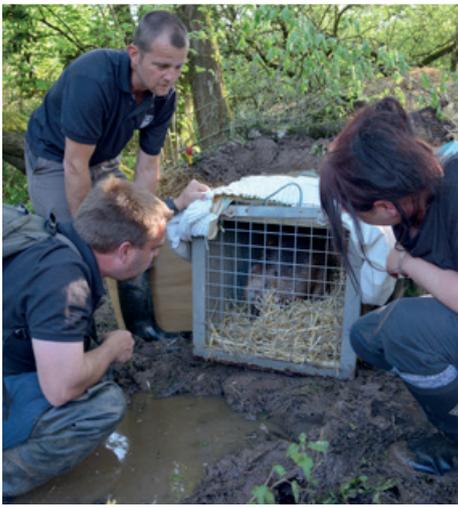
Two artificial lodges were constructed on the edge of the large pond, providing refuge and helping the animals to settle into the release location. The pair of beavers were released separately into the lodges. Transferring their bedding from the holding facility or carrying crate was used as a technique to provide the animals with a familiar scent enabling them to accept their new surroundings. Photos: Nick Upton

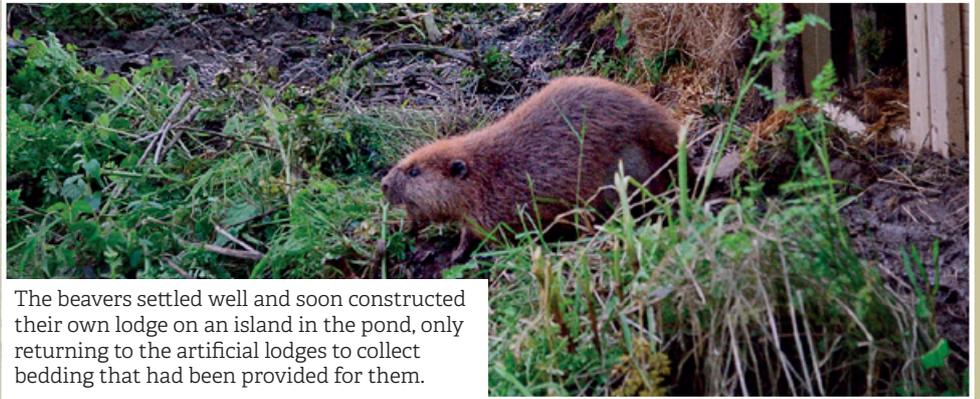
The beavers settled well and soon constructed their own lodge on an island in the pond, only returning to the artificial lodges to collect bedding that had been provided for them.

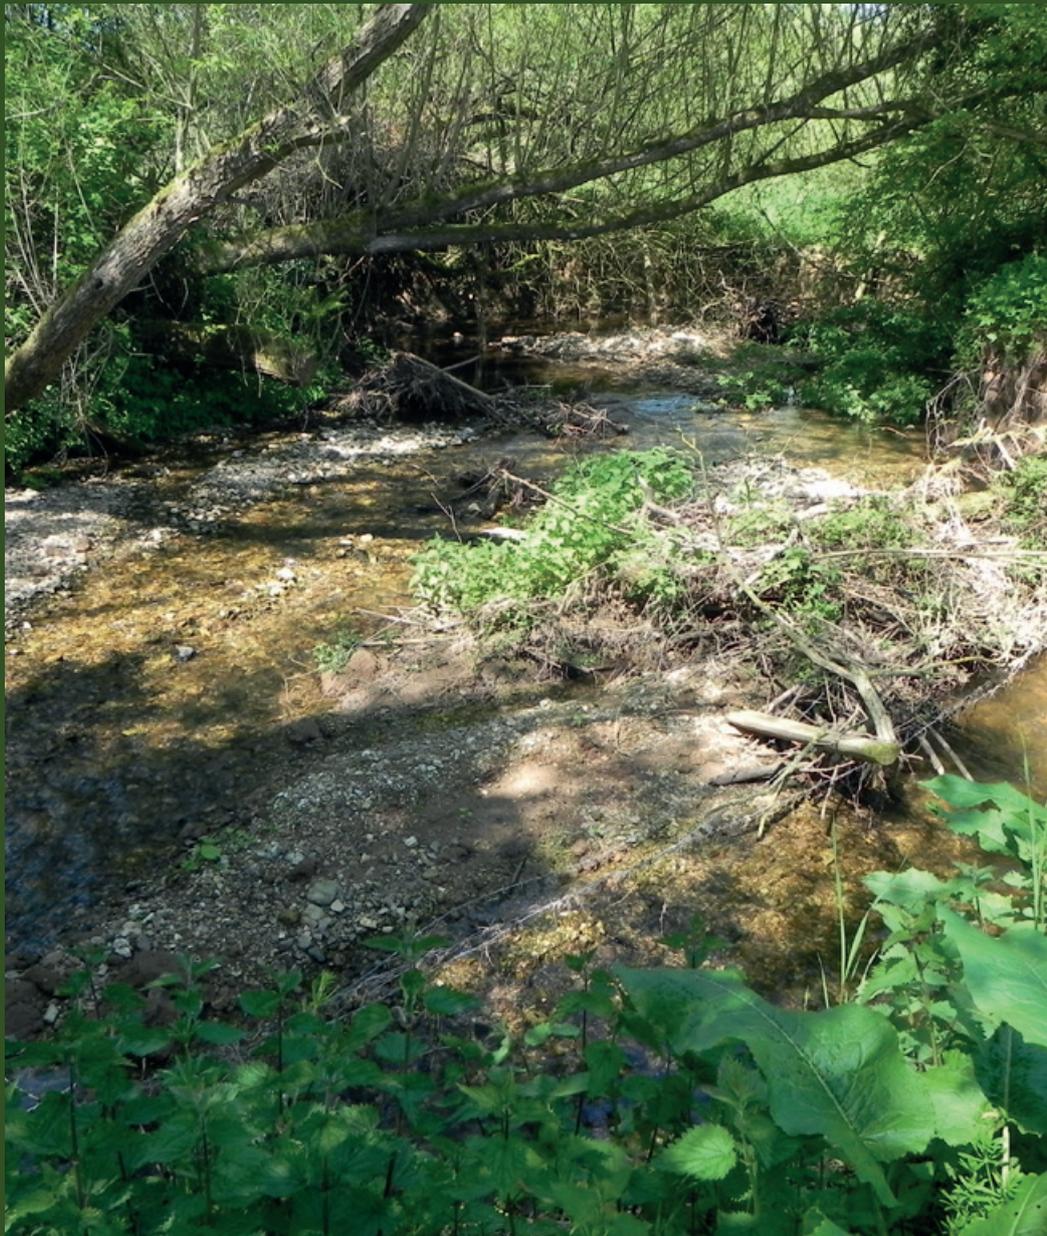
When the beavers were released, it was not clear if they would build dams in the River Tale itself. Subsequently, many of the dams that have been built in the main channel have not persisted through the winter months. However, the construction and natural erosion of the dams has reintroduced dynamic natural processes that are largely absent from our rivers and streams. Where the channel had been deepened and straightened, the beaver activity is re-meandering and raising the bed levels. Gravels and larger sediments are deposited behind the dams and are redistributed as the dams erode, enhancing gravel structures such as sediment bars and riffles, and encouraging localised areas of erosion and scour. This provides a range of important habitats for fish (such as trout and bullhead) and macroinvertebrates.

The presence of ephemeral beaver dams on the main channel has re-connected the river with the floodplain, creating new flow pathways in times of flood, depositing nutrient-rich silts back onto the floodplain, and improving water quality downstream.

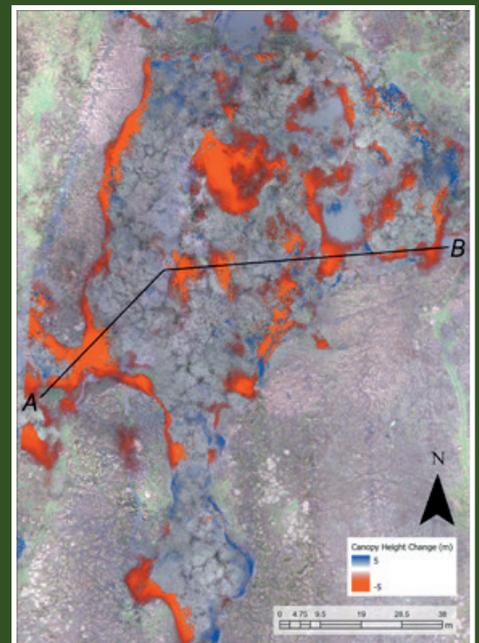
Figure 6.9 Aerial image showing where areas of the canopy have increased in height or been reduced. Numerous areas of canopy have been lowered by beavers, which has increased light penetration and canopy height variability. The cross section indicated on the map, intersects a part of the canopy which has experienced extensive felling.

It was anticipated that some trees would be felled/coppiced, and under-storey vegetation would respond. Drone photogrammetry and spatial data analysis was used to capture and quantify changes to vegetation structure across the site, resulting from beaver activity. Winter feeding signs surveys recorded that 209 trees were impacted. Photogrammetry has shown beavers have strongly influenced woody vegetation structure - a reduction in canopy heights and an increase in canopy variability, with a greater range of tree shapes/sizes than before beaver reintroduction.

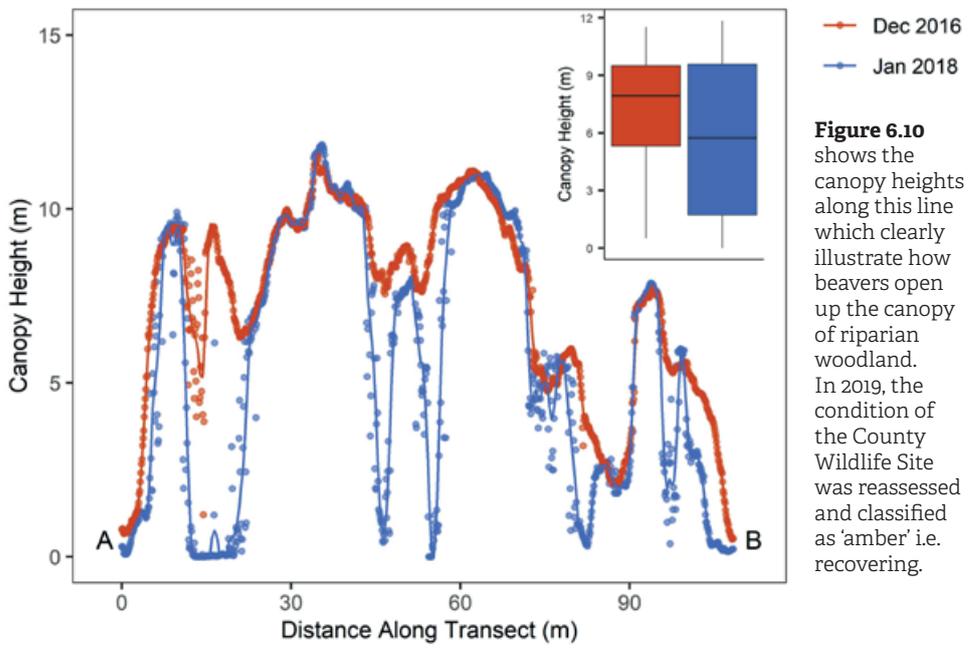
Figure 6.10 shows the canopy heights along this line which clearly illustrate how beavers open up the canopy of riparian woodland. In 2019, the condition of the County Wildlife Site was reassessed and classified as 'amber' i.e. recovering.

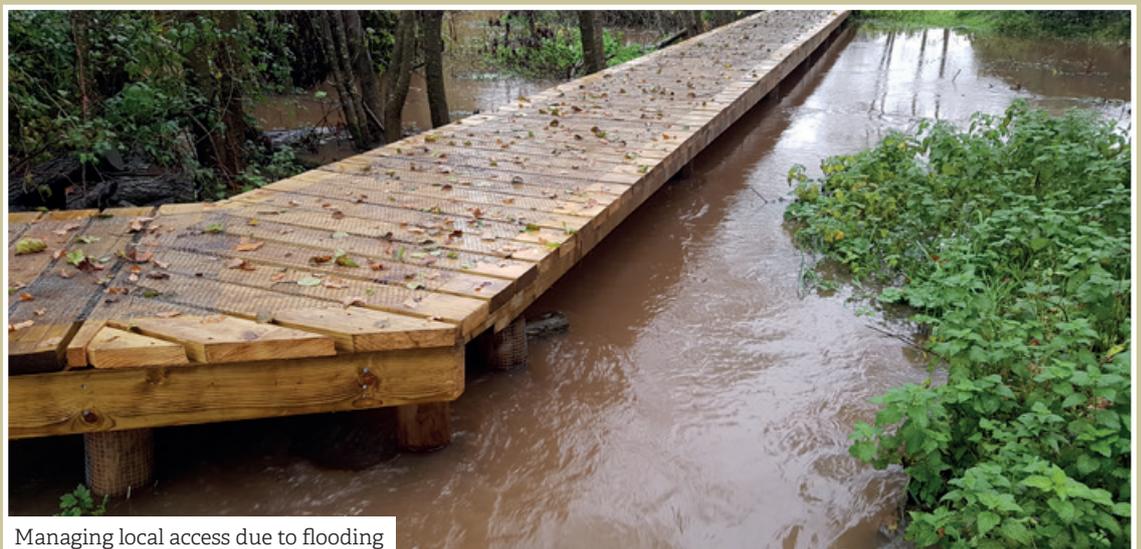
Beaver engineering of the watercourse has reconnected it with its floodplain enabling significant volumes of water to be stored. This has, however, impeded access across the site on-foot and for light farm machinery. The solution was to build a short section of boardwalk in 2019.

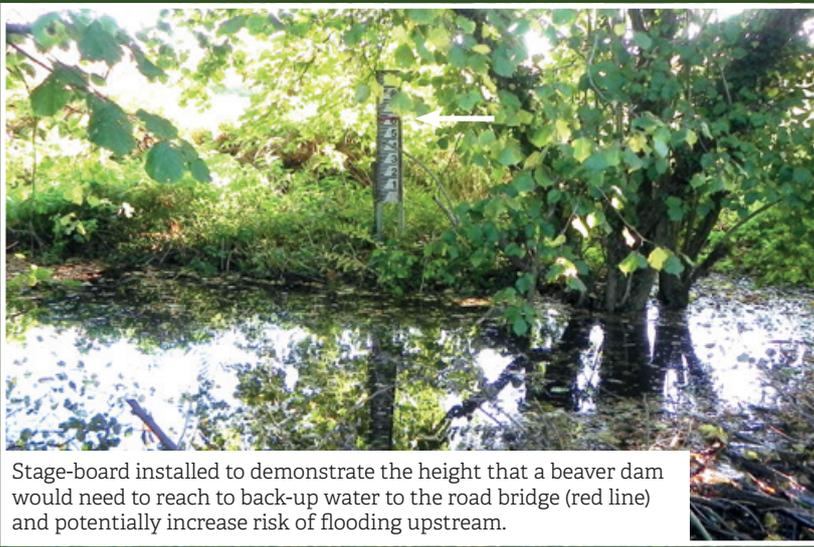
Stage-board installed to demonstrate the height that a beaver dam would need to reach to back-up water to the road bridge (red line) and potentially increase risk of flooding upstream.

The landowners historically cleared the main river channel downstream of their property of large woody debris, due to concerns that it increased flood risk. As a result of beaver damming activity a conversation began as to the potential increase in flood risk that might result. The construction of a 2D hydraulic model predicting the extent of flooding allowed a stage-board to be installed to show where water levels had to reach, before flooding of properties occurred. This modelling showed that, in the beaver dam's current location, there is no increased flood risk, unless the dam was built to the height of the red line (see image) i.e. 1.5 m

above current bankfull depth. It was also identified that dams in the river reach adjacent to the house should be removed, as these could back-up flow in critical locations, increasing flood-risk to properties.

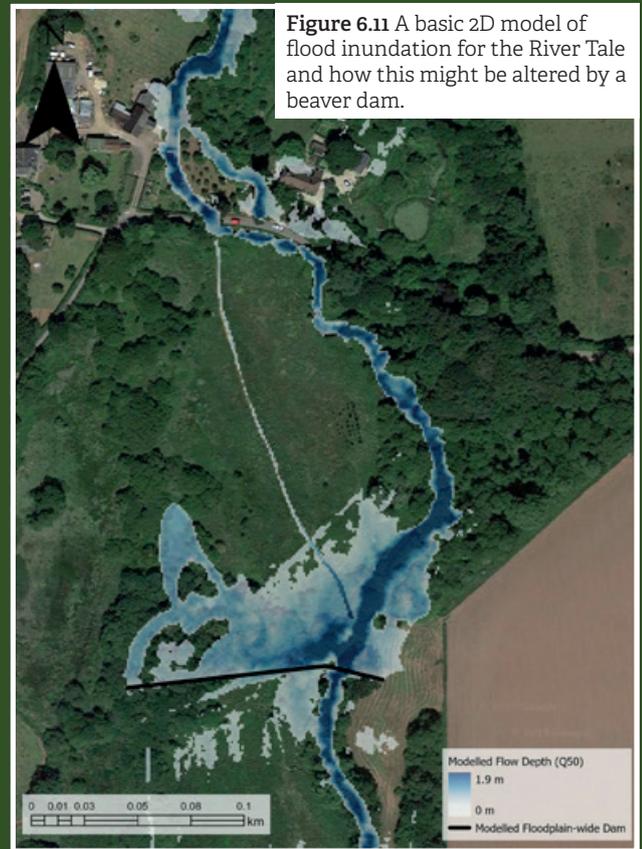
Figure 6.11 A basic 2D model of flood inundation for the River Tale and how this might be altered by a beaver dam.

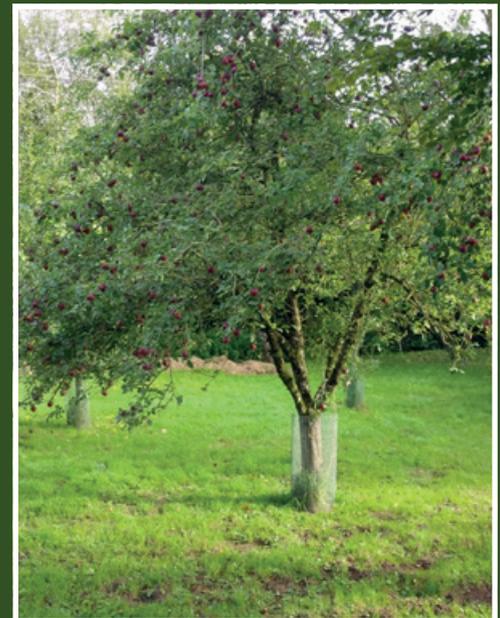
Riverside orchards are particularly at risk from beaver activity - both from feeding on apples and coppicing of the trees. Apple trees within an orchard adjacent to the CWS were identified and protected prior to the release of the beavers. Since release the beavers have been feeding on windfall apples and have damaged one of the few unprotected trees. All remaining trees have now been protected and discussions are ongoing to reduce the visual impact of the tree guards.
