BODMIN MOOR, EXMOOR AND DARTMOOR

RESTORATION

Restoration planning, methods and outcomes

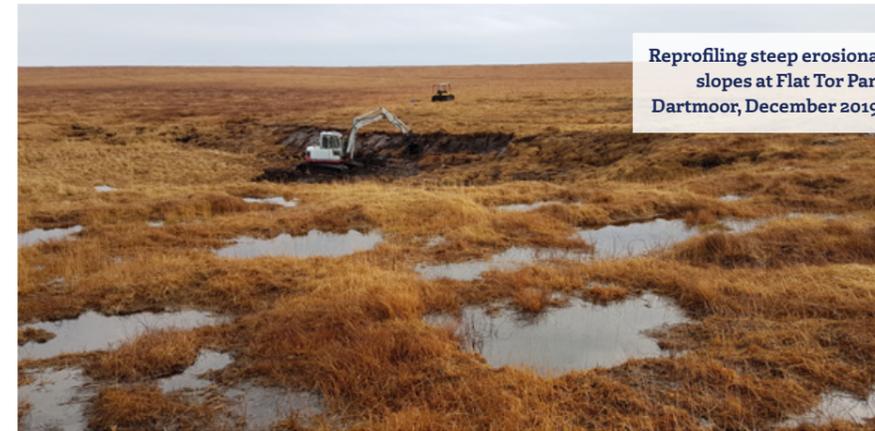
Reprofiling steep erosional slopes at Flat Tor Pan, Dartmoor, December 2019.

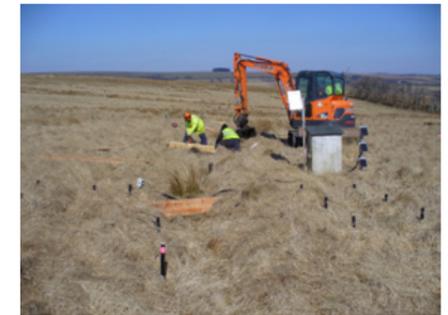
Restoration in progress within the Spooners monitoring catchment, Spooners, Exmoor.

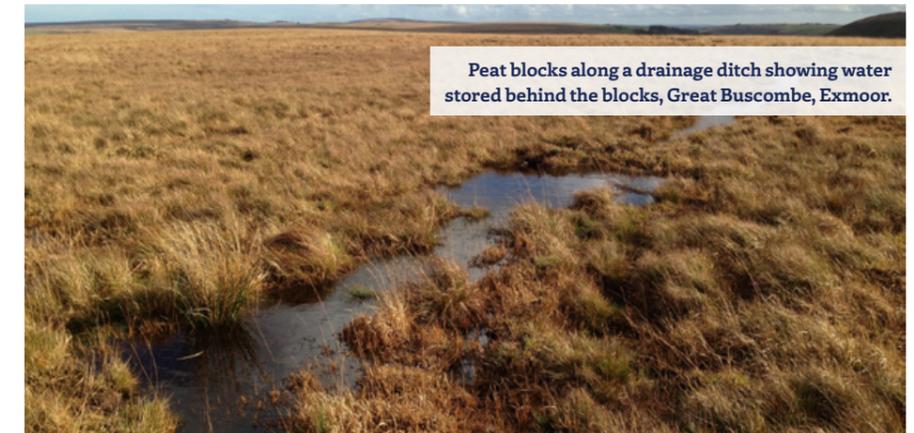
Peat blocks along a drainage ditch showing water stored behind the blocks, Great Buscombe, Exmoor.

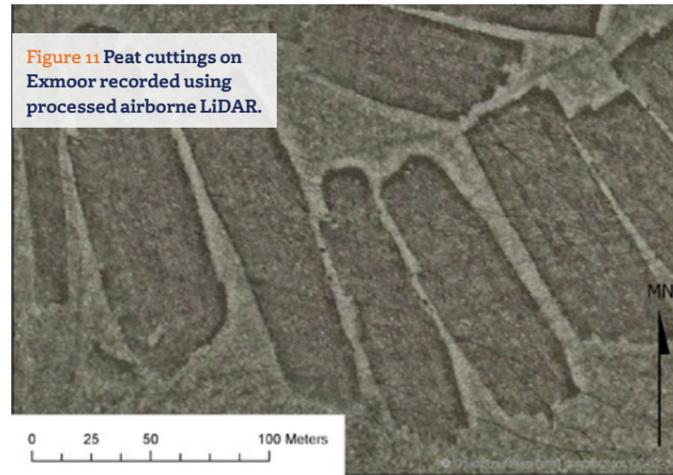
Figure 11 Peat cuttings on Exmoor recorded using processed airborne LiDAR.

at up to centimetre accuracy. These surveys clarify features such as individual peat cuttings (Figure 11) which are often hard to distinguish by human eye on the ground.

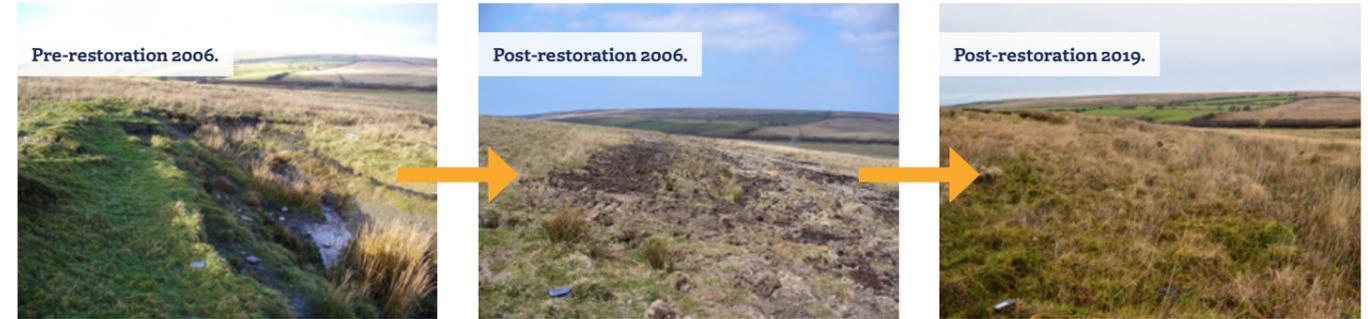
Figure 10 Fixed point photography from Roostichen, Exmoor; pre-restoration (2006), immediately post-restoration (2006) and 13 years post-restoration (2019).

Peatland restoration aims to bring about landscape change. In order to demonstrate and monitor landscape change associated with restoration fixed point photography is used (Figure 10). There are now over 60 pre- and post-restoration locations across Exmoor and Dartmoor.
