CHAPTER 1:

Living with beavers on the River Otter

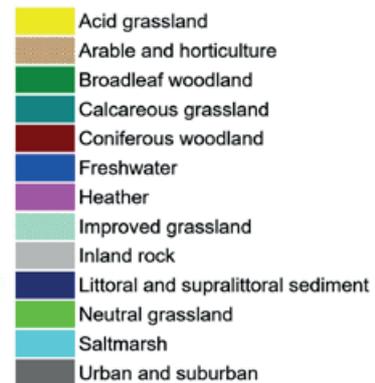
Figure 1.1 Land use in the River Otter Catchment

The catchment covers ca. 250 km² (25,010 ha). Land use composes: 50% improved grassland, 28% arable and horticulture and 5% urban and suburban. The remaining 17% is covered by woodland, other grasslands, heathland, freshwater, saltmarsh, littoral sediment, and supra-littoral sediment¹.

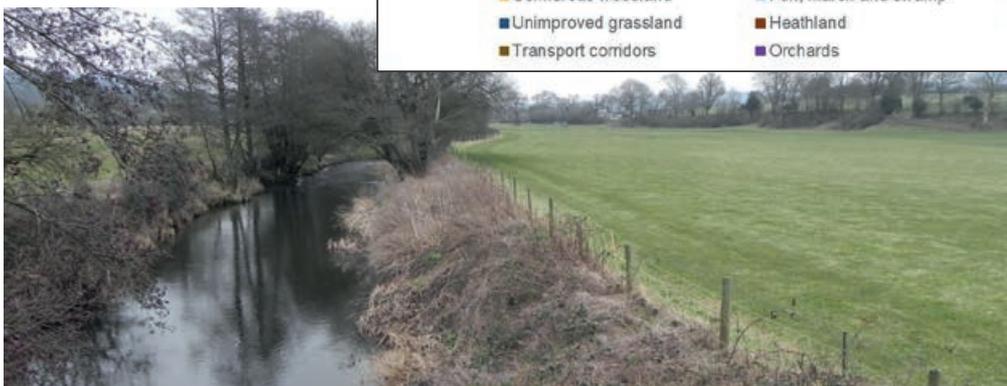
→ **Figure 1.3** Aerial Photographic Interpretation of the land-use within a 30 m buffer of all of the key watercourses within the catchment identifies the land-uses most likely to be affected by the activities of beavers. The total area of this buffer is 3,378 ha.

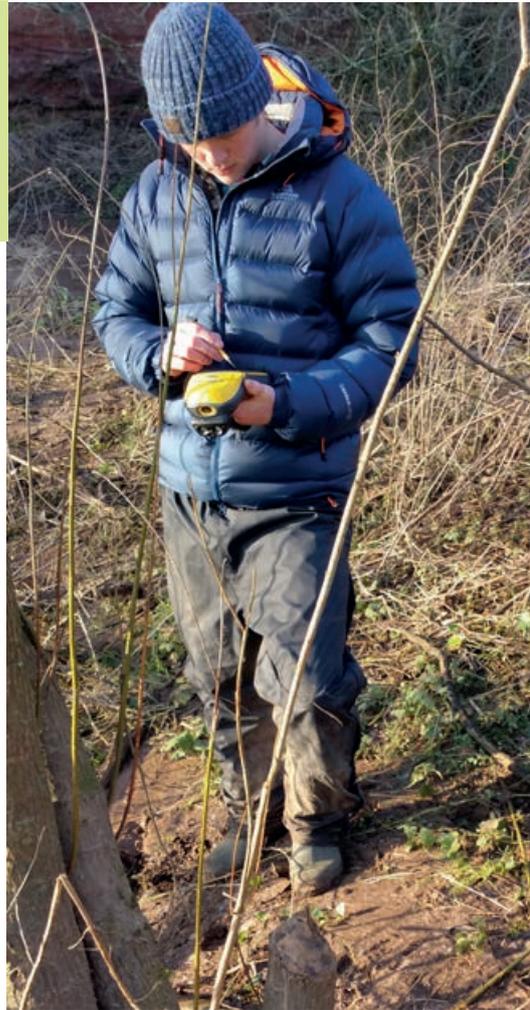
→ The ROBT team were able to increase the efficiency of survey work through the acquisition of a Trimble Geo7 GPS device that allowed the user to input data directly into a Geographical Information System (GIS).

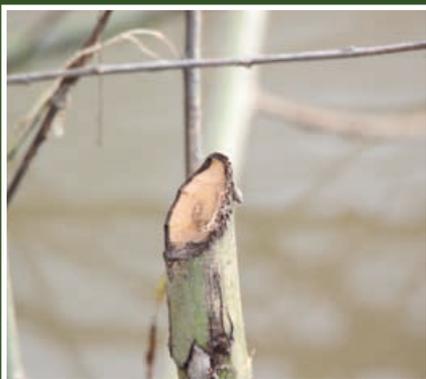
Low Impact – fewer than 20 cuts (branches or stems), all <7 cm in diameter, and / or stripped bark area <10 hands (ca. 0.2 m²).

Figure 1.4 Browsing by beavers on trees was recorded into three impact classes using this classification

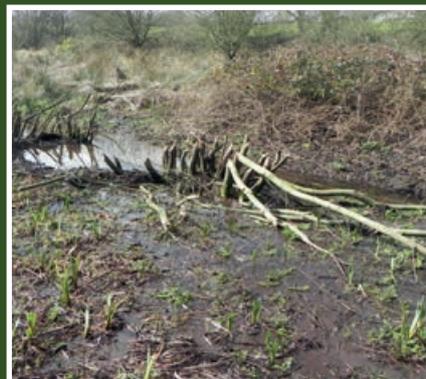
Medium Impact – greater than 20 cuts (branches or stems), or with at least one >7 cm in diameter, and / or a stripped bark area >10 hands (ca. 0.2 m²).

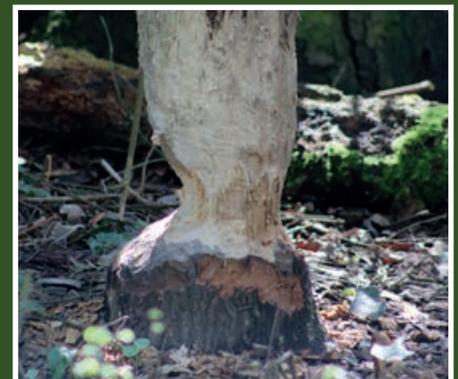
Major Impact – Tree / main stem with a diameter >20 cm, either felled or noticeably incised (i.e. beyond the cambium and noticeably into the sapwood, and not simply bark stripped).

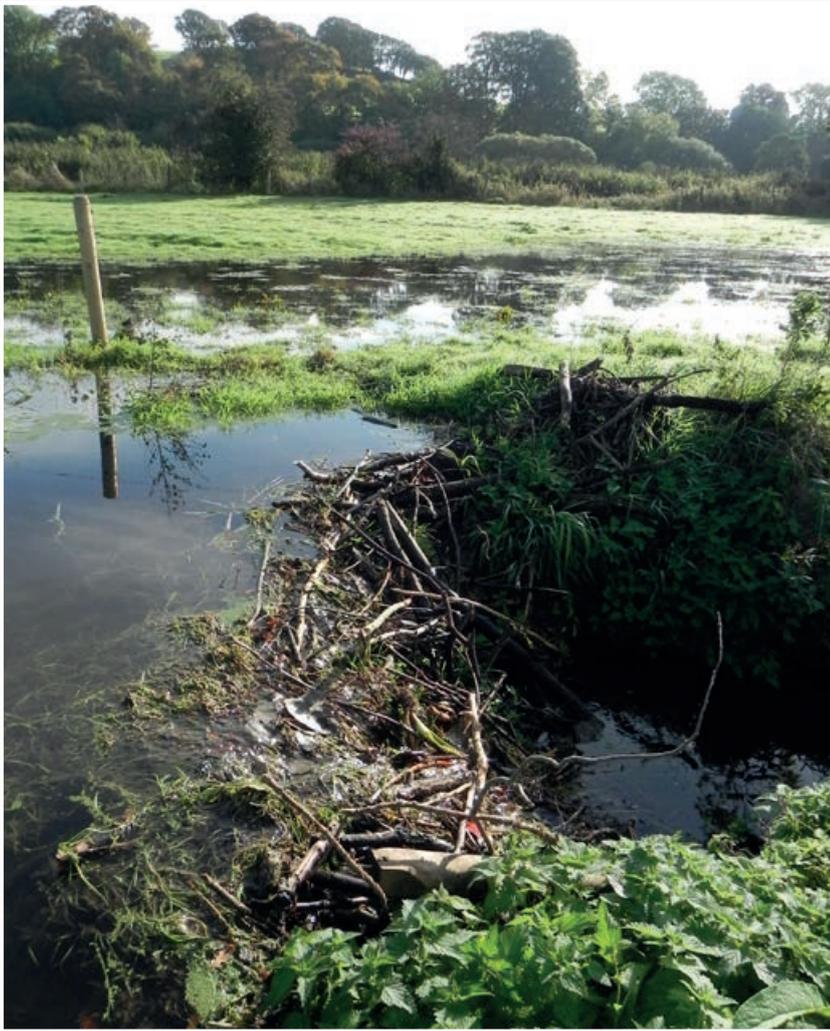
← **Colaton Raleigh stream** is a groundwater fed watercourse that originates on Colaton Raleigh Common. The watercourse has been heavily modified by land drainage and runs in a ditch network through floodplain pastures before joining the main River Otter in Otterton. Within this network, beaver dams have been built in 13 locations since September 2016. This is a low gradient drainage system and although high flows and human intervention have regularly changed the dam heights, a few have been washed out in their entirety. Three of the smaller dams have also been drowned out by other dams built downstream of them.

In October 2019, eight dams were present and due to the flat nature of the topography, 813 m of the ditch network were impounded by them.

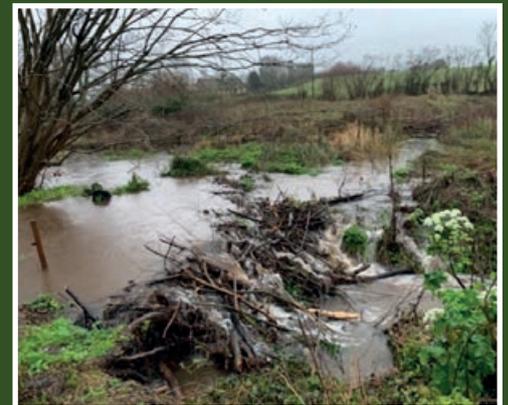
↑ The **Budleigh Brook** rises on Bicton Common before passing through Yettington and East Budleigh. Six dams have been constructed in the channel and two of these have pushed water out of bank, with retaining bunds also built by the beavers on the adjacent floodplain.

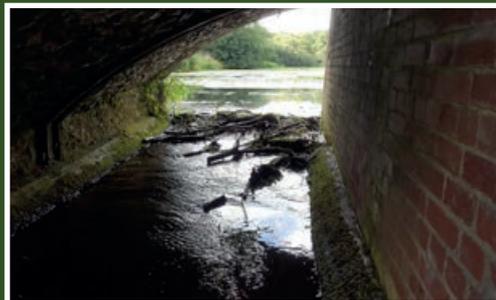
→ **Otterhead Lakes**. Dams have been built in seven locations upstream of the top lake/reservoir, although these are dynamic features due to high flows. In total 11 dams were recorded in various watercourses in this complex in October 2019. Owing to the steeper gradient here, they impounded only 246 m of watercourse (which includes the main lake with slightly elevated water levels at this time).

The beavers are continuing to build a small dam on the outfall structure to the upper lake, and this is removed regularly by volunteers on the site. Beaver dams have also been built in the overflow channel from the top lake. One was around the outfall structure which was removed, and others have been retained.

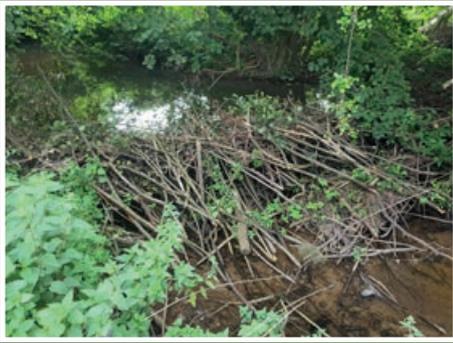
← The **Clyst William Cross (upper Tale)** site, where additional beavers were released (to improve genetic diversity) in 2016, is where the largest number of dams have been built. In the main River Tale, dams have been built in eight different locations. The high-energy nature of this watercourse has made these dams very dynamic, often ephemeral, features. It is estimated that a total of 22 individual dams were built in eight locations on this reach of the Upper Tale over the 4 year period since 2016. Only one was in place in October 2019; a large 1.8 m high dam structure, which was impounding 208m of the stream and was bypassed by side channels cutting across the river floodplain.

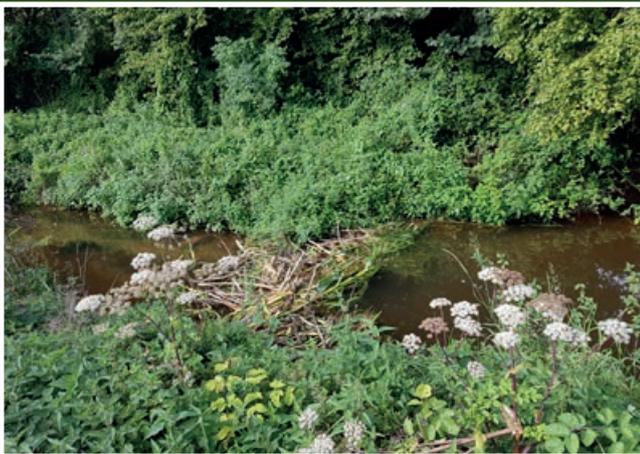
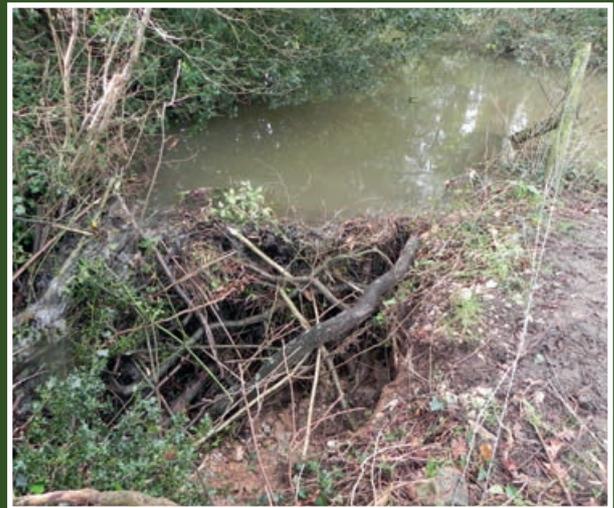
↓ In the **mid-River Tale**, dams have been built in four locations, often during low summer flows to access adjacent food resources (maize). At two of these sites, dams were unacceptable to some, but not all, of the landowners, and any signs of beavers starting to rebuild the dam were repeatedly removed by ROBT staff; in one case on 10 occasions over a period of three weeks. High flows commonly erode these dams and going into autumn 2019 only one 0.6 m high dam was in place. **Case Study 6** discusses the conflicts with land drainage, and associated issues between neighbours in this flat landscape.

↑ The **Cadhay stream** near Ottery St Mary was the location for the first beaver dams in the catchment. In early 2016, a 0.8 m high dam was built in a drainage ditch impounding water in low-lying pasture where a flood relief channel discharges peak-flows. This was initially removed by the landowner because of the impacts on land-drainage, and then again twice subsequently by ROBT staff. Two other smaller dams were also removed in the same ditch to prevent them becoming established. They have not been rebuilt since.

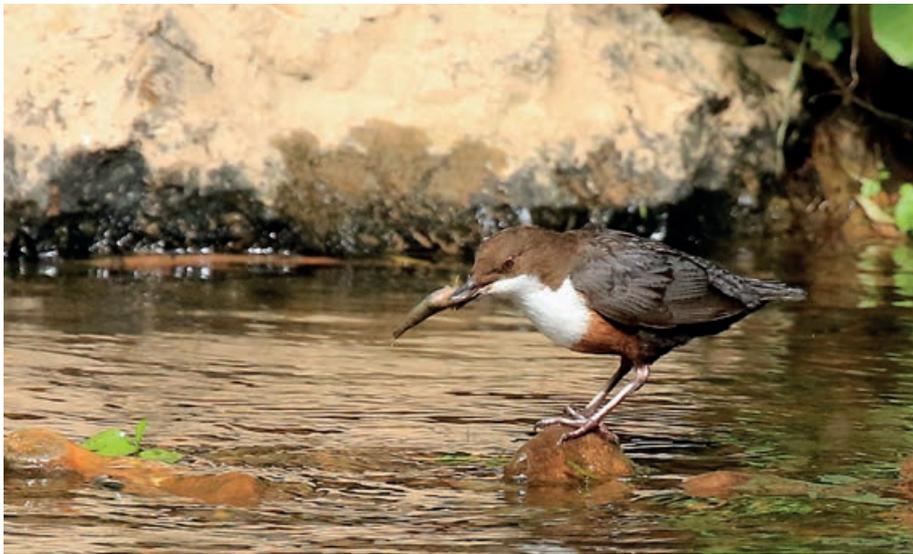
↑ The increased channel heterogeneity created by beaver dams, creates new riffle habitat for dippers and bullhead.

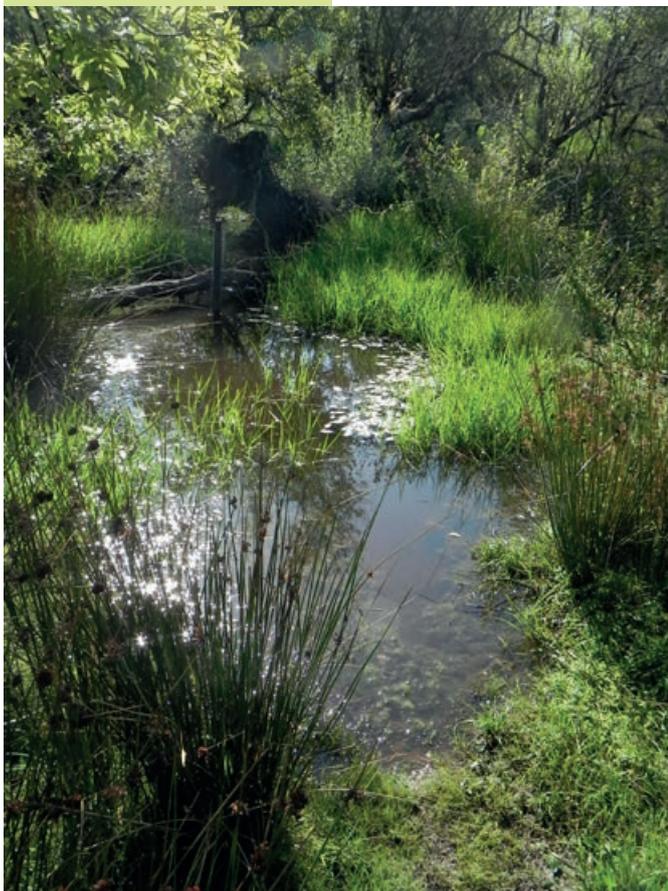
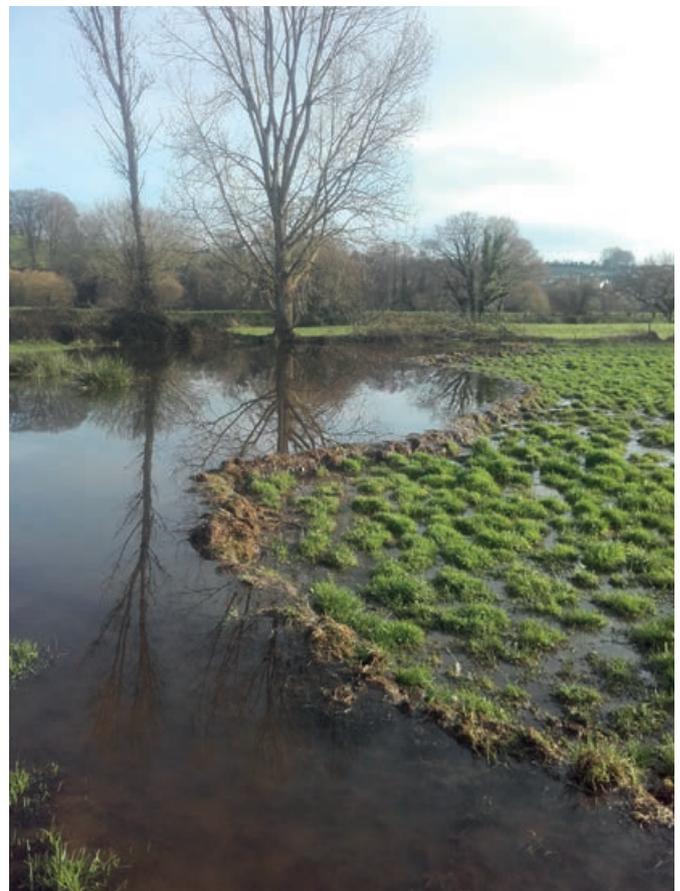
↓ Beaver dams create a mosaic of wetland habitats which benefit a wide range of wetland species.

↑ Wetland habitats formed where water spills over and around a beaver dam often support important emergent vegetation communities.

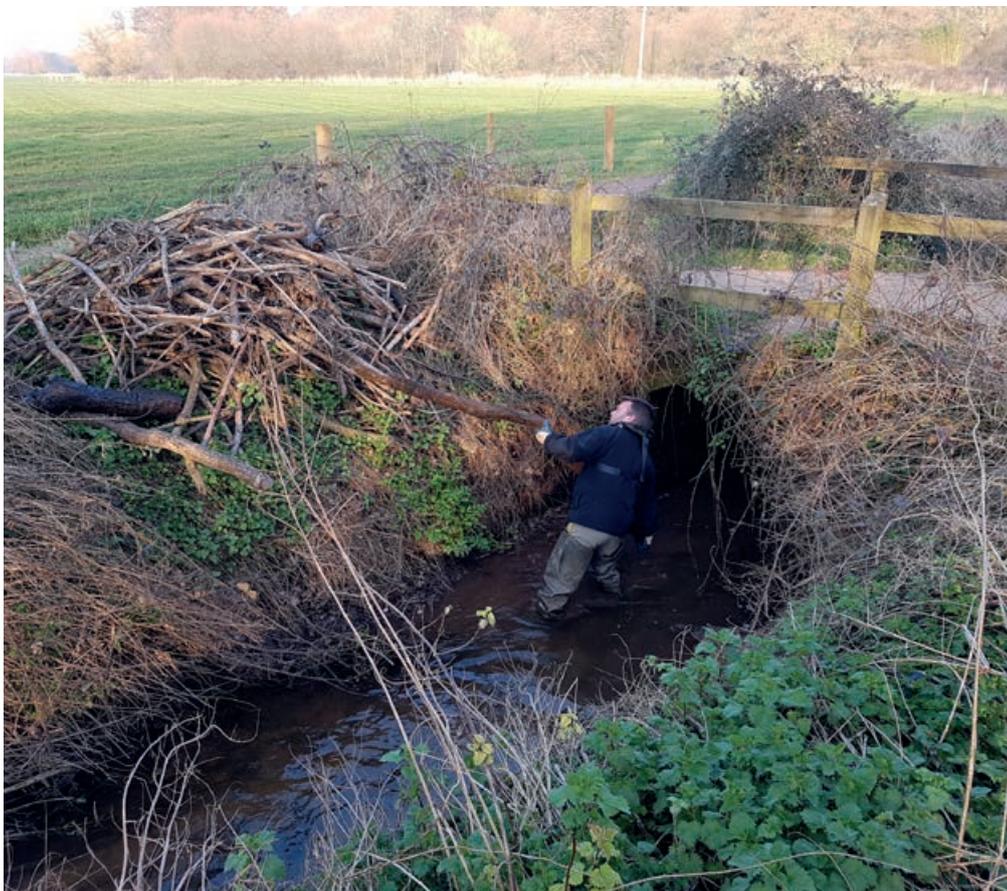
Elsewhere beaver activity was thought to be the reason for a blocked culvert, but on closer inspection this was shown to be flood debris which was removed by the ROBT team.

← ROBT Staff clearing a blocked culvert

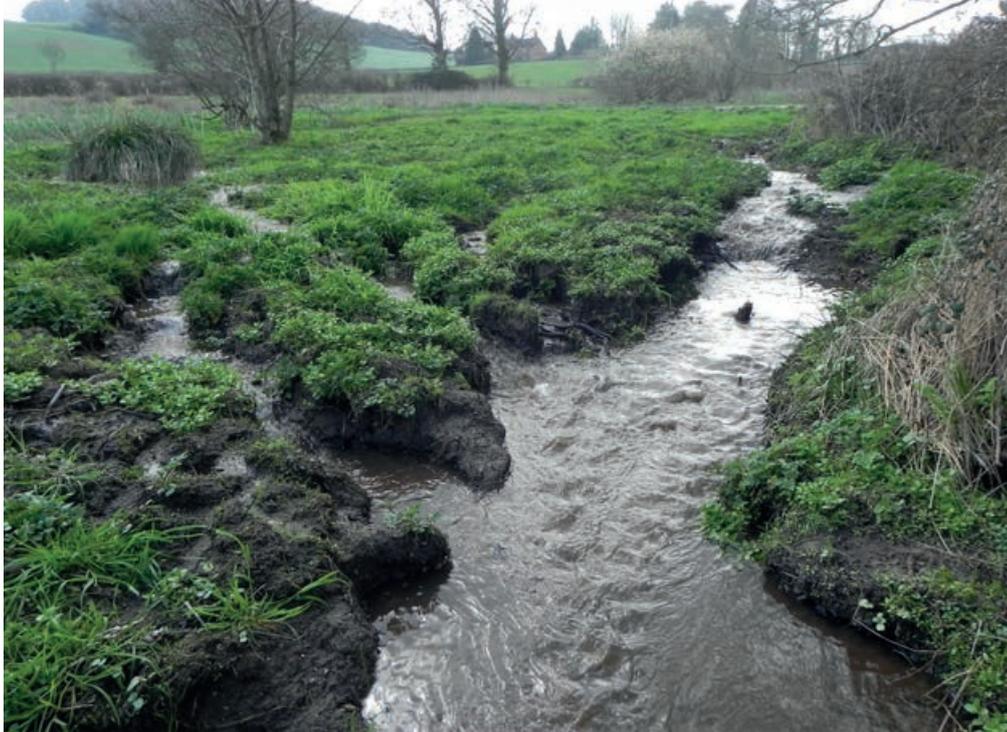
← An avulsion (channel rerouting) event has been observed on the Budleigh Brook where a beaver dam originally built in the stream, now extends across the floodplain. The new network of multi-thread channels has begun to incise, revealing rounded pebbles and cobbles, indicative of previous channel beds, deposited before the channel was artificially straightened and deepened.

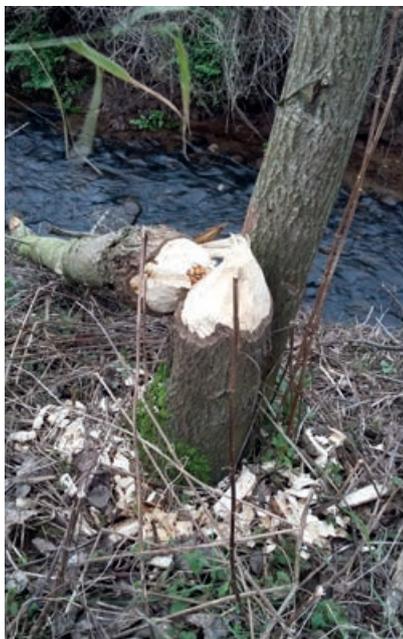
← Within the Otterton territory, one stem of a young row of streamside aspen *Populus Tremula* trees has been coppiced.

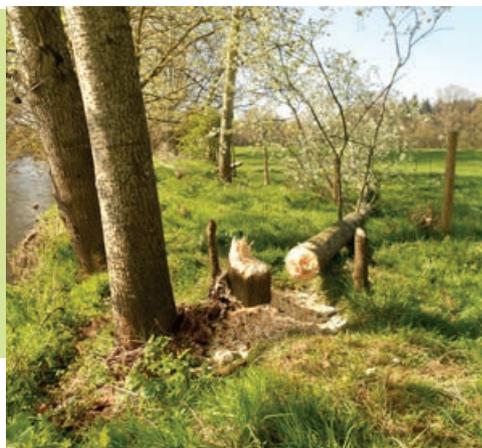
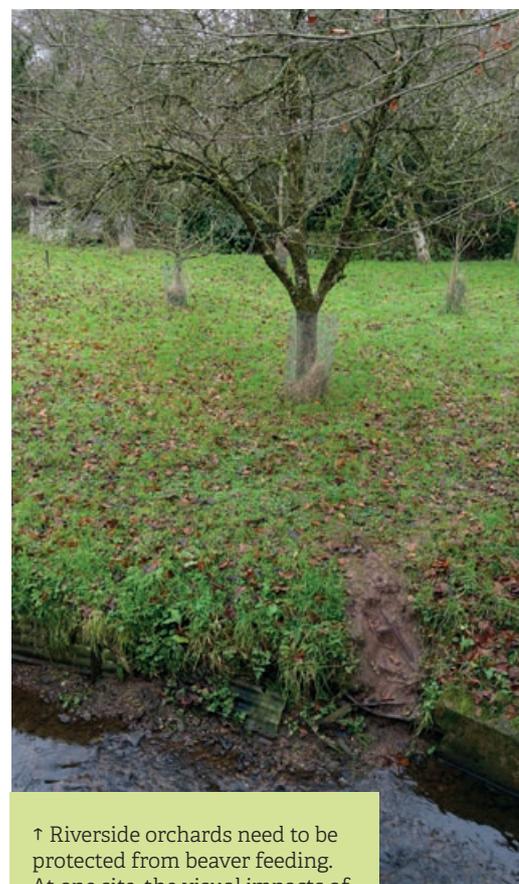
↑ Riverside orchards need to be protected from beaver feeding. At one site, the visual impacts of the tree guards remain a concern for the landowner, as does the fact that the beavers are taking the fallen apples before they are collected.

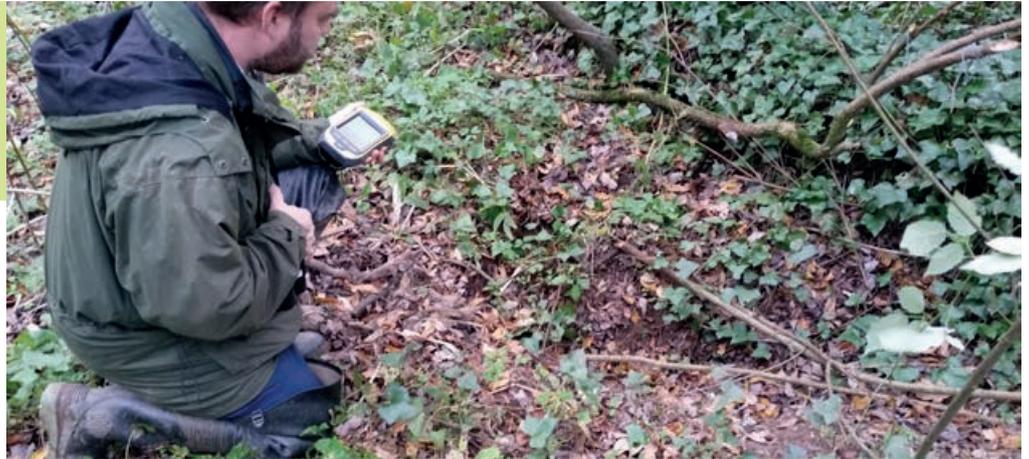
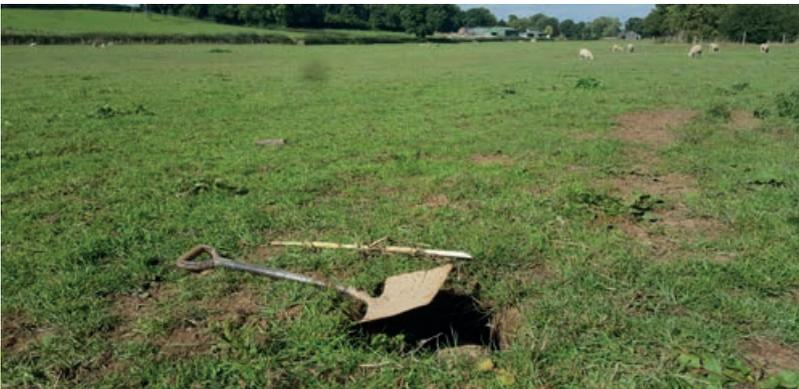
↑ Conflicts have arisen on one site where land is grazed close to the riverbank. Two burrows have collapsed where cattle and sheep are present, and these required back-filling by the ROBT Field Officer. This conflict could be mitigated by providing a riparian buffer strip with restricted livestock access.

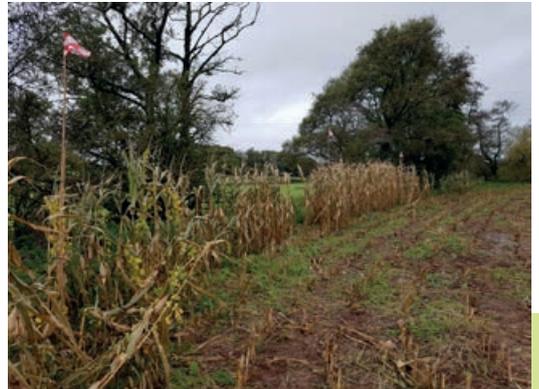
↑ To alert the operators of heavy machinery, flags were installed at one site when they were harvesting maize.

On the opposite bank where the maize field was due to be harvested, there was a risk of forage harvesters causing burrow collapses, and damage to farm machinery. To keep harvesting machinery away from potential burrows, bamboo canes with flags attached were placed at 10 m intervals along a 50 m strip. The flags were clearly visible above the maize, mitigating the risk of damage to farm machinery. The standardized approach for the assessment of costs based on data from the *John Nix Pocketbook*¹⁶ (see below) can be used to estimate the gross margin loss of leaving an unharvested strip against the watercourse. In this case a 5 m strip along 50 m of watercourse (0.025 ha) is estimated to be worth £22.10 for one harvest.

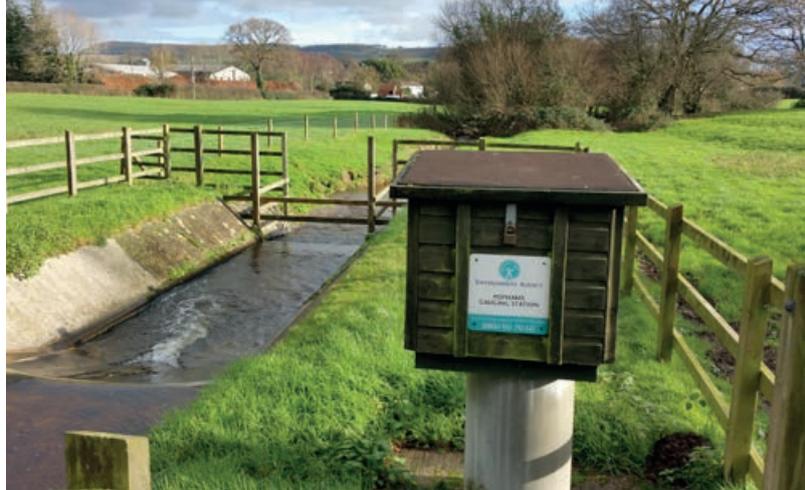
↑ Environment Agency monitoring equipment is routinely surveyed - no beaver impacts have been recorded in any of the infrastructure throughout the River Otter catchment.

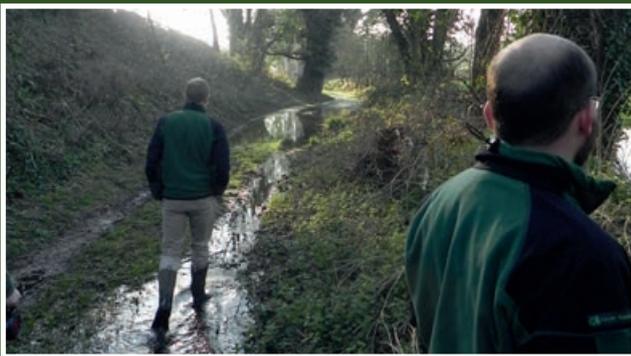
↑ Rights of way and paths

There are 46 km of Public Right of Way which lie within 30 m of all the watercourses within the catchment. The footpaths in the vicinity of Otterton in the lower part of the valley are very heavily used with, for example, >100,000 people recorded in 2017/18. There have been three instances where trees have been felled by the beavers onto these footpaths in the four years between 2015 and 2019. In each case, the landowner, Clinton Devon Estates were swift in their removal. In total, this response took approximately one day of an Estate worker's time with a chainsaw. No other impacts on footpaths have been identified.

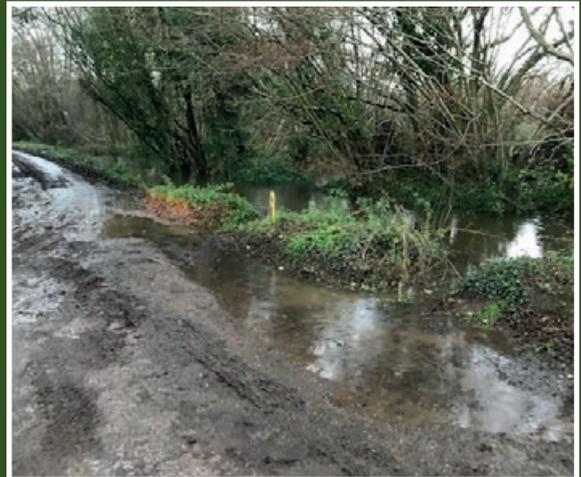
↑ Other access routes

One farm access track used by local residents as a permissive path to avoid walking on the road has been flooded to a maximum depth of 30 cm on occasions during the winter of 2018/19. This was due to the height of a beaver dam in a heavily modified watercourse, within a floodplain. The presence of the beavers and dam was being accepted by the landowners, but when this track became waterlogged, the dam was managed to bring the water-level down by up to ca. 50 cm. This same dam was submerging the corner of a pasture field and fence-posts, and so its reduction also alleviated this issue. In this situation, regular monitoring and management was straightforward. However, more sustainable, expensive solutions could be employed at this location such as raising the track level with stone, or installing a flow device. At the current time, this 'little and often' management has been the most cost-effective mitigation option.

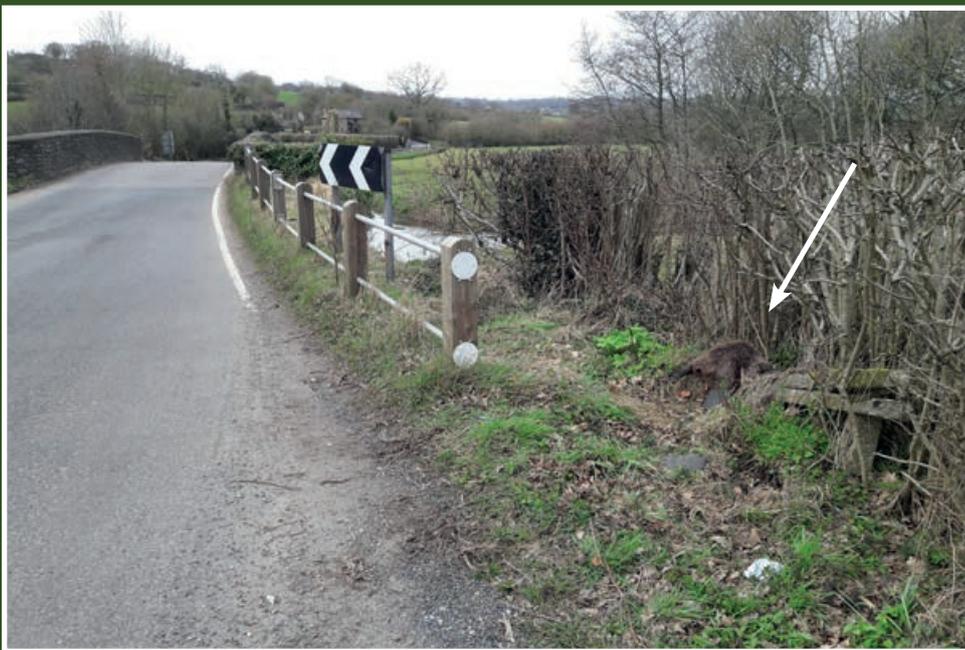
↑ Highways impacts

A single highways impact was detected during the 5-year trial. A beaver dam built within 20 m of a small country lane caused impounded water to encroach slightly onto the edge of the road. The Highways team at Devon County Council were made aware and did not identify a need to intervene. The landowners, Clinton Devon Estates, have occasionally reduced the crest level of the dam to lower water levels and mitigate this impact, and allay the concerns of a local resident. The location is adjacent to the Estate's Forest yard with 24 hour access required.

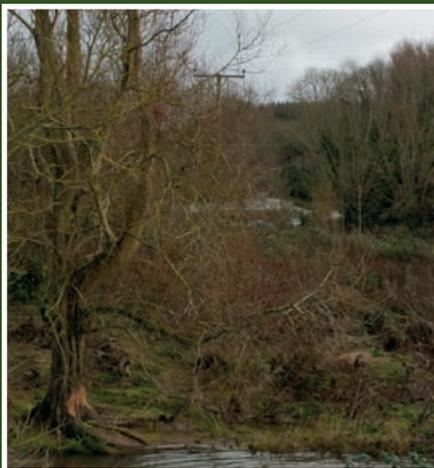
← Electricity or telecommunications infrastructure

There have been no recorded negative effects on electricity or telecommunications infrastructure. On two occasions large riverside willow trees growing adjacent to powerlines were being gnawed by beavers, and were proactively protected to prevent any detrimental impacts. In one case, in consultation with the landowner, Western Power Distribution decided to coppice the willow tree, as is normal practice when trees grow within ca. 3 m of power lines.

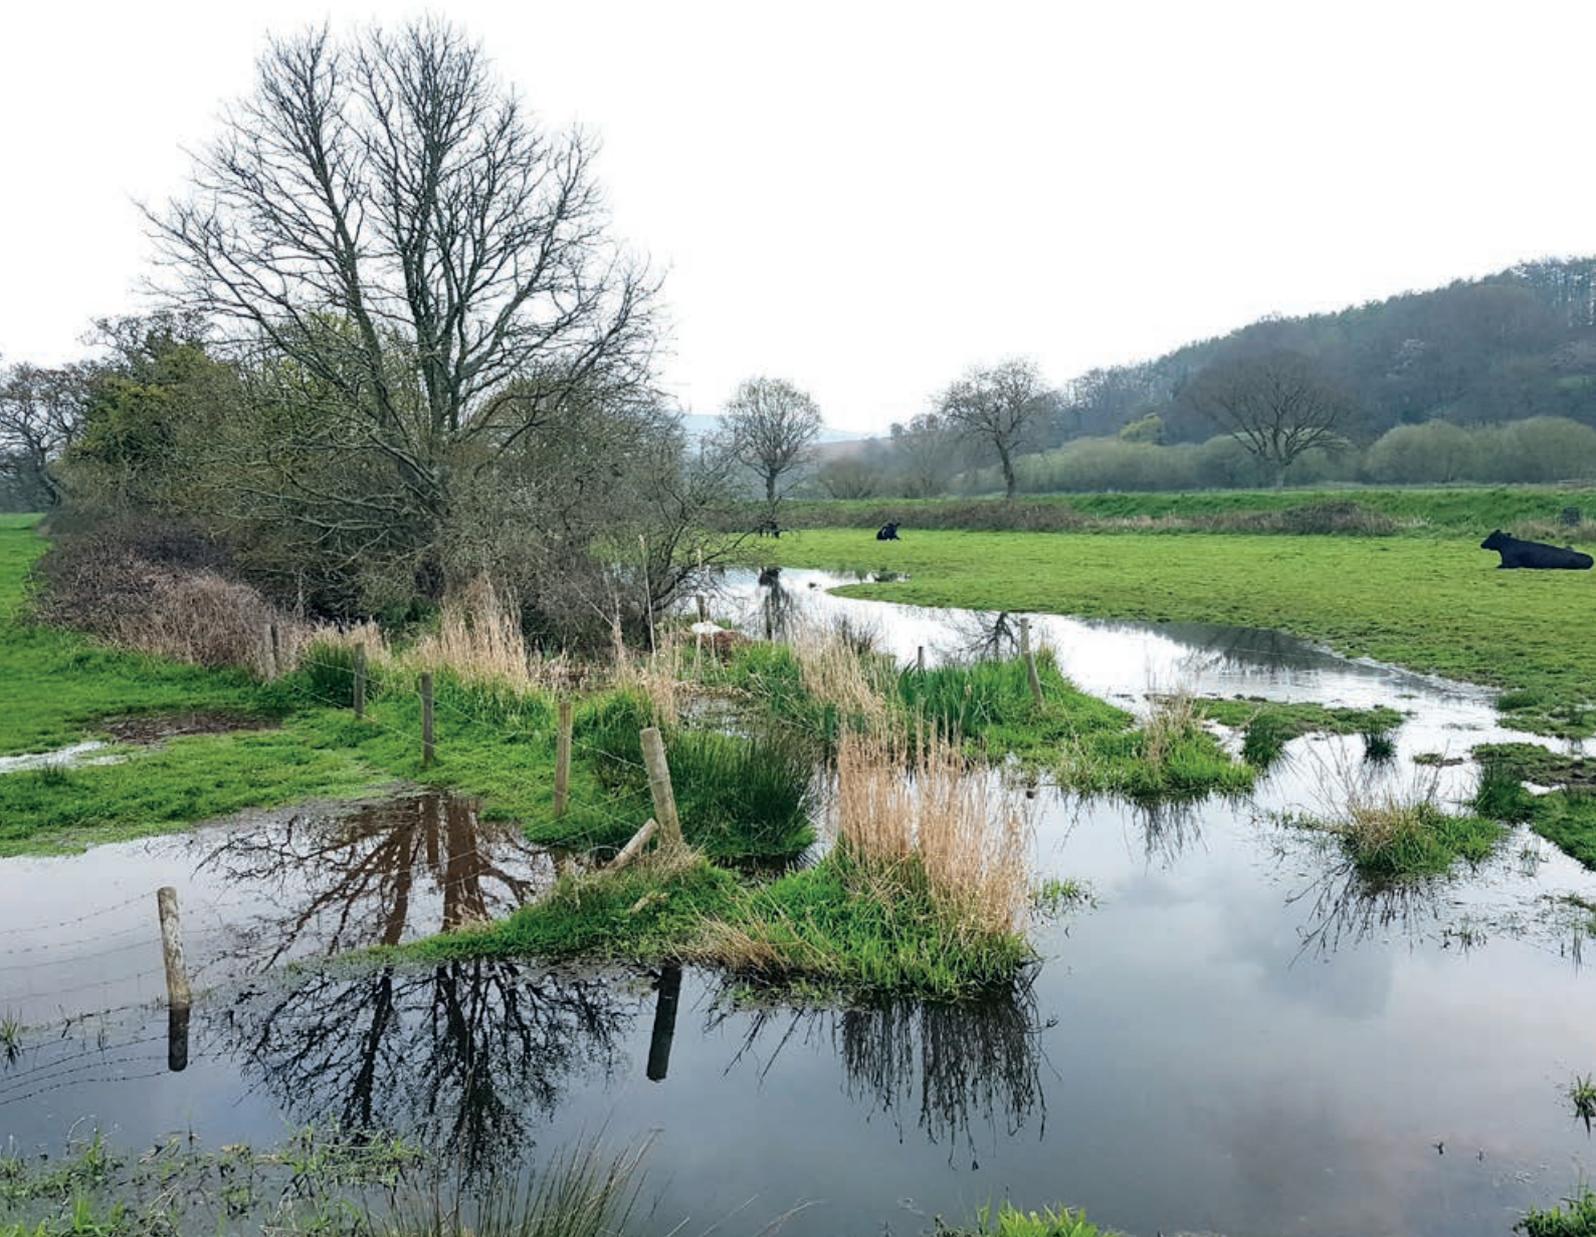
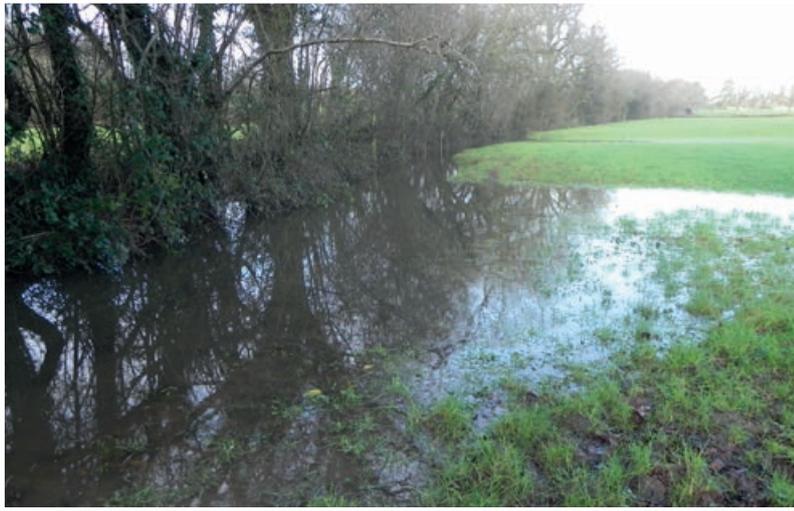
← Cadhay Stream

In winter 2015/16 a series of three beaver dams was constructed in a drainage ditch in the floodplain north of Ottery St Mary. One of the three dams was 80 cm in height and 0.5 ha of the low-lying adjacent pasture was flooded and waterlogged for a number of weeks during the winter period. This dam was removed by the tenant farmer and ROBT staff. Due to the season, there was no direct financial impact on the farm business, except the time taken by the farmer to manage the dam.

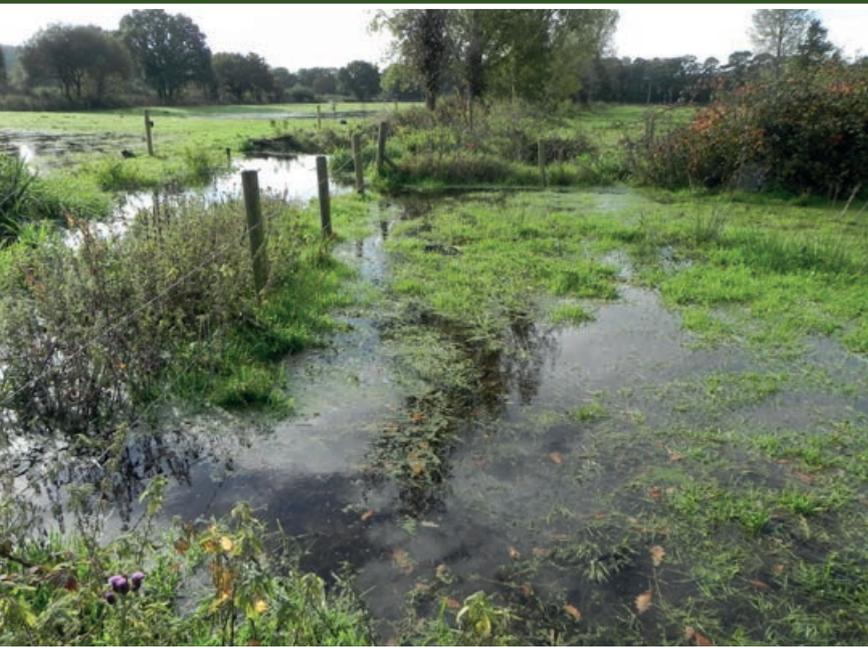
← Colaton Raleigh Stream (Case Study 1)

The Colaton Raleigh Stream site received the greatest intensity of beaver management resources.

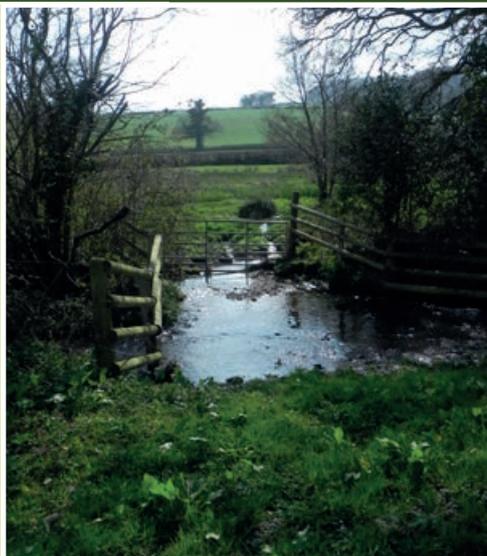
← Budleigh Brook (Case Study 2)

The sequence of dams on the Budleigh Brook upstream of East Budleigh have had a measurable impact on the peak flows downstream and the raised water levels have impacted on 0.4 ha of Grade 1 arable land.

A backlog of water behind a beaver dam prevented the sowing of 0.4 ha of organic 'first early' potatoes. The estimated gross margin forgone was £1495. Additionally, seed potatoes had been purchased that could not be planted. This constituted a further cost of £600. These estimates were made using data for organic first-early potatoes¹⁷.

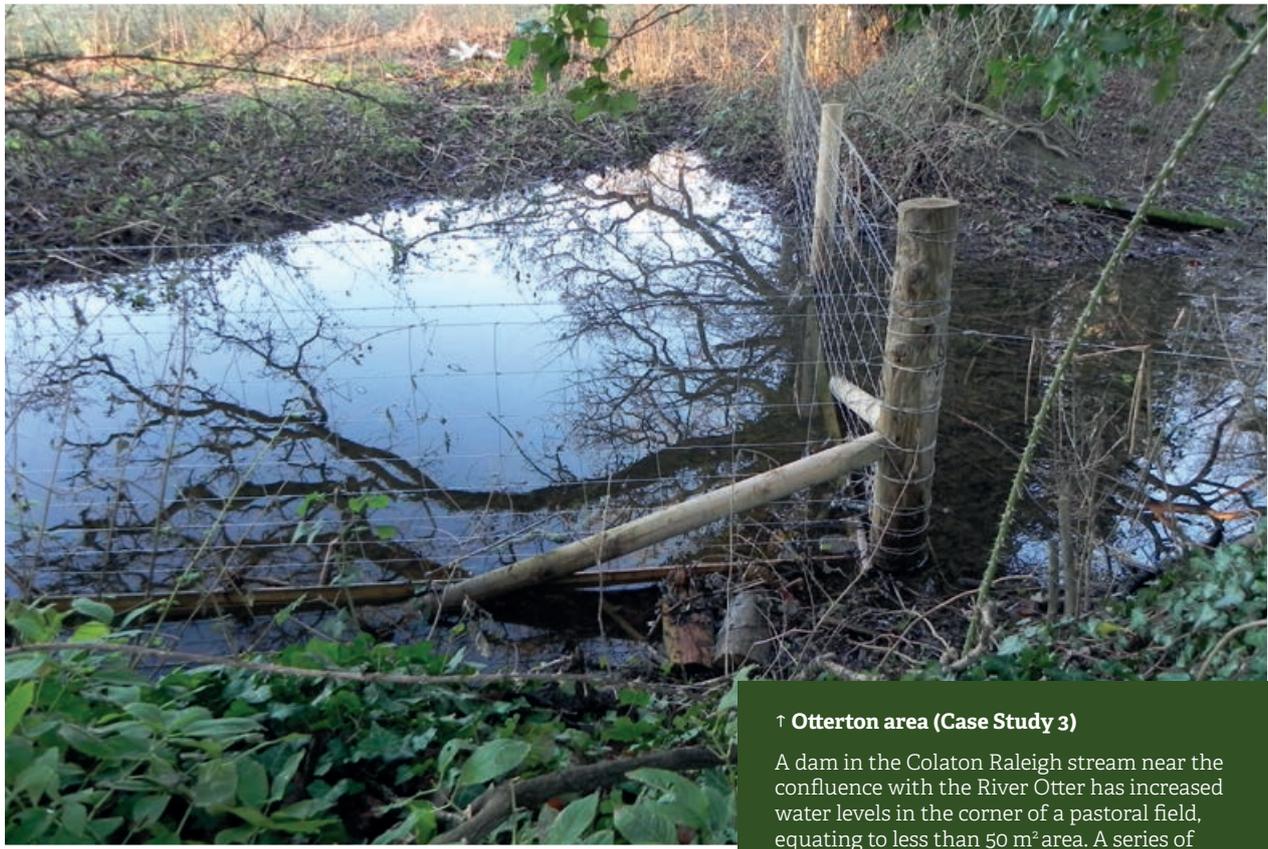
↑ **Otterton area (Case Study 3)**

A dam in the Colaton Raleigh stream near the confluence with the River Otter has increased water levels in the corner of a pastoral field, equating to less than 50 m² area. A series of fenceposts in this field corner have also been partially submerged during wet periods which is likely to reduce their lifespan. This dam was impacting on an access track, which combined with concerns by local anglers about potential sea trout passage in autumn, has led it to be reduced in height on a regular basis.
