CHAPTER 3: Ecosystem Services

Character of the River Otter hydrology

Understanding how beavers can influence flood risk

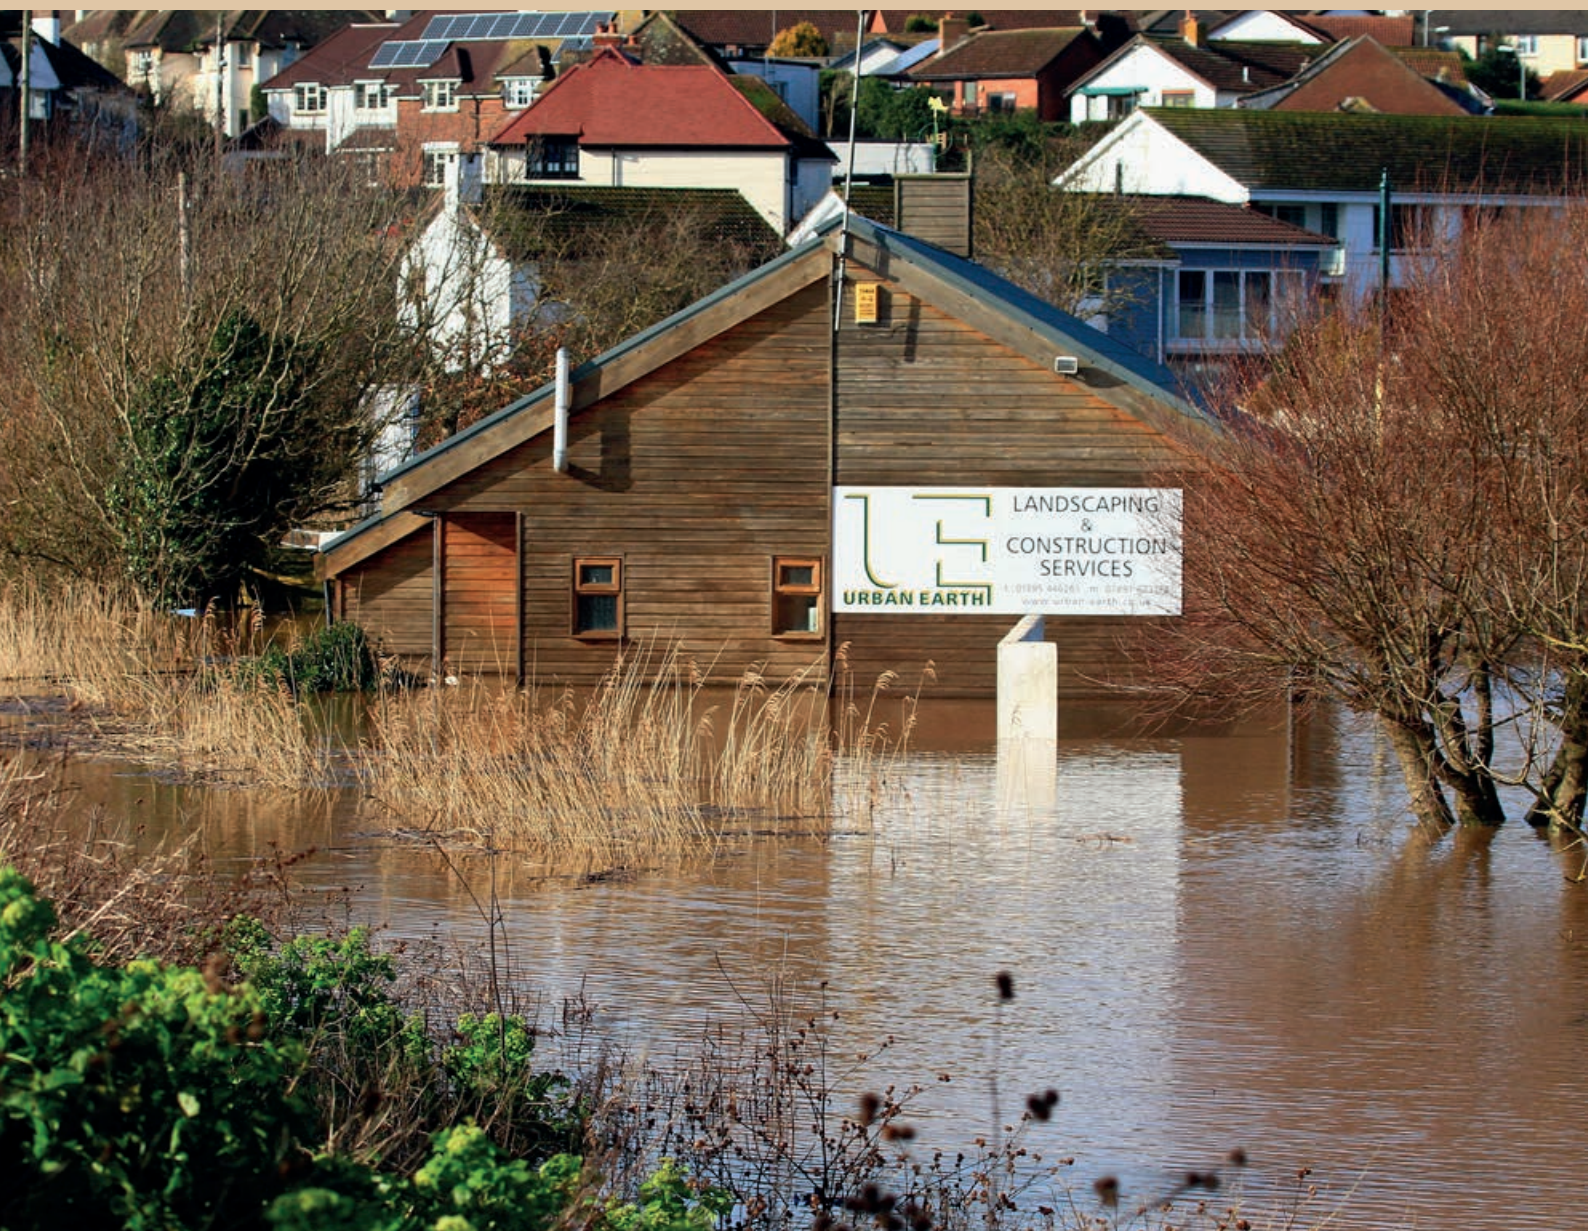
Flooding in the lower River Otter Valley

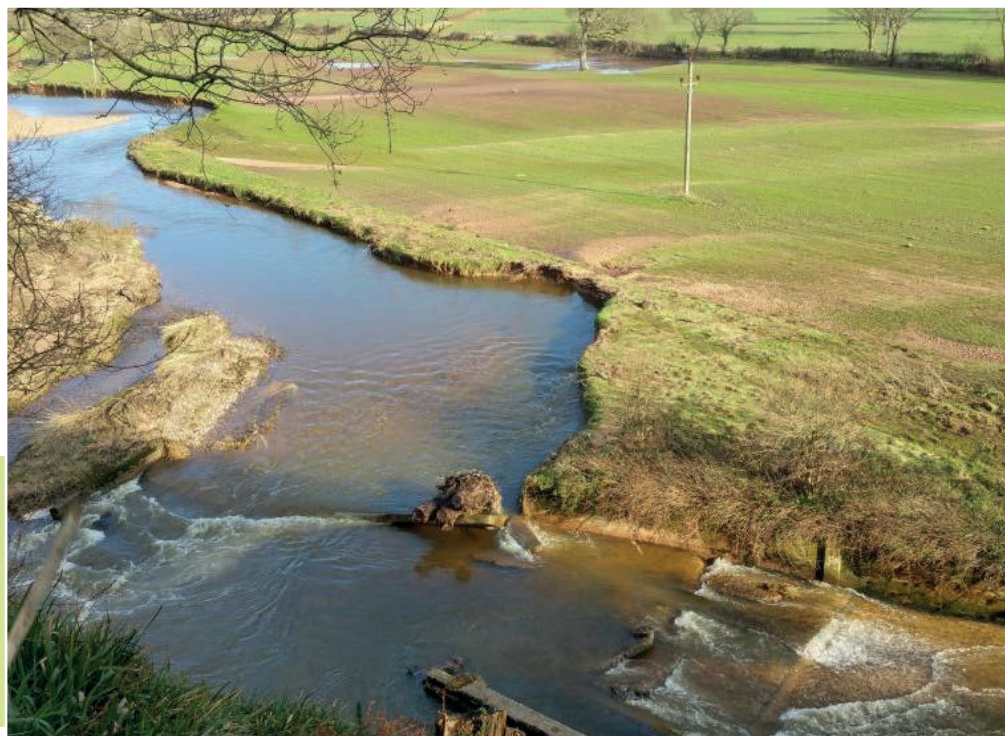
→ Where the river flows across the lower floodplain, the sandy nature of the soils and floodplain deposits makes the planform very mobile, with channel meanders, oxbow lakes and channel cut offs, where the river is allowed to flow overbank.

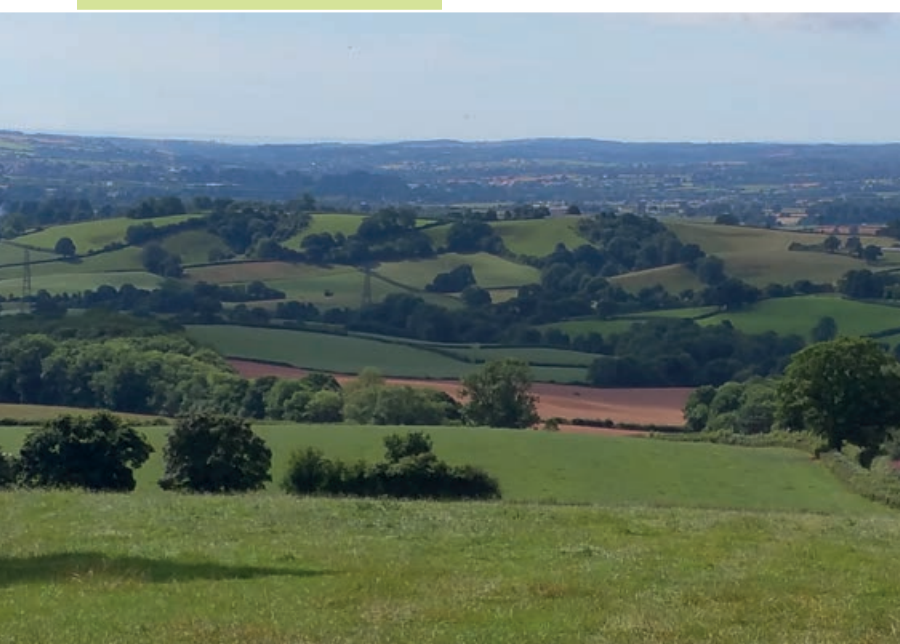
↓ The geology of the River Otter provides important baseflows from groundwater and also makes it a very spatey or flashy catchment, which reacts quickly to heavy rainfall in the Blackdown hills.

There is a large difference between the maximum daily mean flow recorded at Dotton, and the maximum instantaneous flow. The flow record at Dotton gauging station on the River Otter for the period 1963 – 2018 shows a mean daily flow of $3.22 \text{ m}^3\text{s}^{-1}$ and a measured Q95 (the flow exceeded for 95% of the time, on average) of $0.97 \text{ m}^3\text{s}^{-1}$. The Q95 represents 30% of the mean daily flow. This is a relatively high percentage and reflects the strong groundwater influence of this river system. Surface water runoff in the Otter catchment is also significant with floods in the catchment characterised by a very rapid rise and fall of water levels, with high flood peaks.

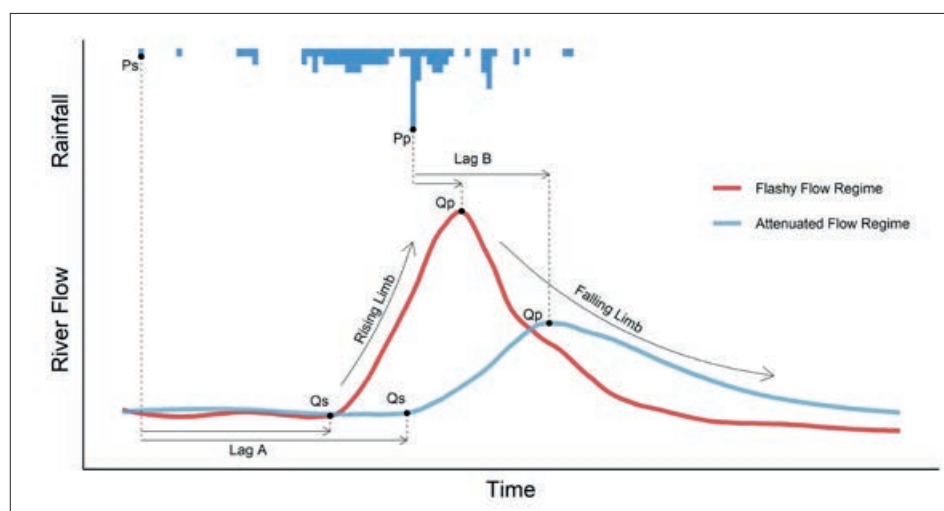
¹ **Figure 3.1** The key hypothesis that the hydrological research tests is whether beaver dams deliver the attenuated hydrograph response (in blue) when compared with pre-beaver flows (in red) or whether flows into beaver dam complexes (in red) might be attenuated as they pass through beaver dams (in blue). 'Lag A' illustrates the time lag between the start of a rainfall event (P_s) to the start of a flow event (Q_s); 'Lag B' describes the lag time between peak rainfall (P_p) and peak flow (Q_p).

Figure 3.1 describes the difference between a 'flashy' or fast response hydrograph (in red), that is typical of intensively-managed landscapes, where the emphasis on water resource management is to move the water from the land to the watercourse as fast as possible, and a more natural, or attenuated, hydrograph (in blue). Of note, the flashy hydrograph rises fast, peaks high and falls fast, with a short duration before water levels return to baseflow. Such hydrographs respond very quickly after heavy rainfall especially when the soil is saturated or has poor infiltration characteristics or is impermeable due to compaction or urbanisation. In contrast, the attenuated hydrograph rises slowly, with a delayed response to rainfall, peaks at a lower level, with a longer duration and often a post-storm baseflow that is elevated, even during dry periods. As such, flashy, or fast response flow regimes pose a greater risk to communities downstream and attenuated flow regimes will reduce flood risk.

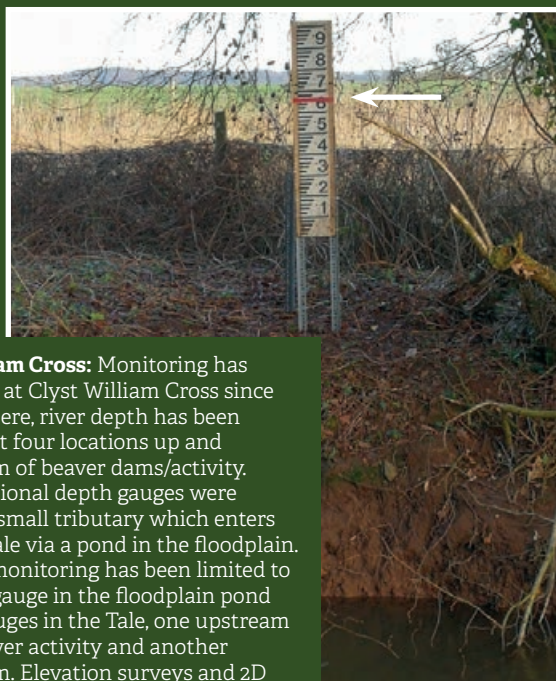
Clyst William Cross: Monitoring has taken place at Clyst William Cross since May 2016. Here, river depth has been measured at four locations up and downstream of beaver dams/activity. Three additional depth gauges were placed in a small tributary which enters the River Tale via a pond in the floodplain. From 2018 monitoring has been limited to one depth gauge in the floodplain pond and two gauges in the Tale, one upstream of core beaver activity and another downstream. Elevation surveys and 2D hydrological modelling of this site has enabled the installation of a stage board to demonstrate the height a beaver dam would need to reach to cause water to back up to the road bridge upstream.

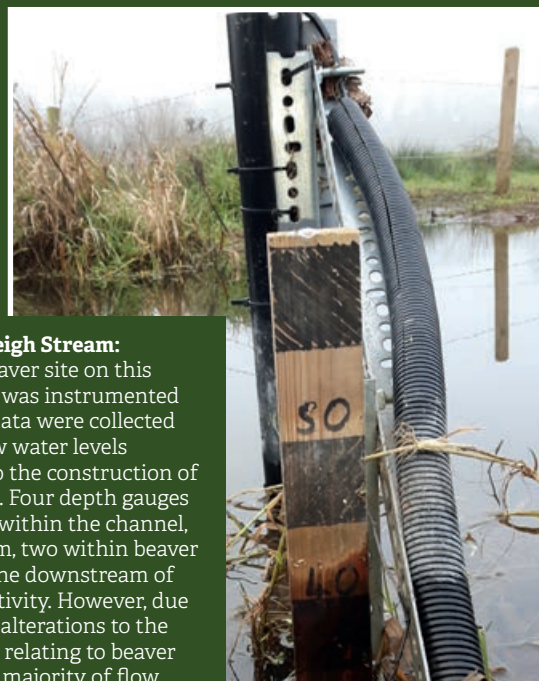
Colaton Raleigh Stream:

The main beaver site on this watercourse was instrumented in 2016 and data were collected showing how water levels responded to the construction of beaver dams. Four depth gauges were placed within the channel, one upstream, two within beaver ponds and one downstream of damming activity. However, due to upstream alterations to the channel (not relating to beaver activity), the majority of flow is no longer conveyed along this channel and consequently, in November 2018, all gauging equipment was removed from the site.

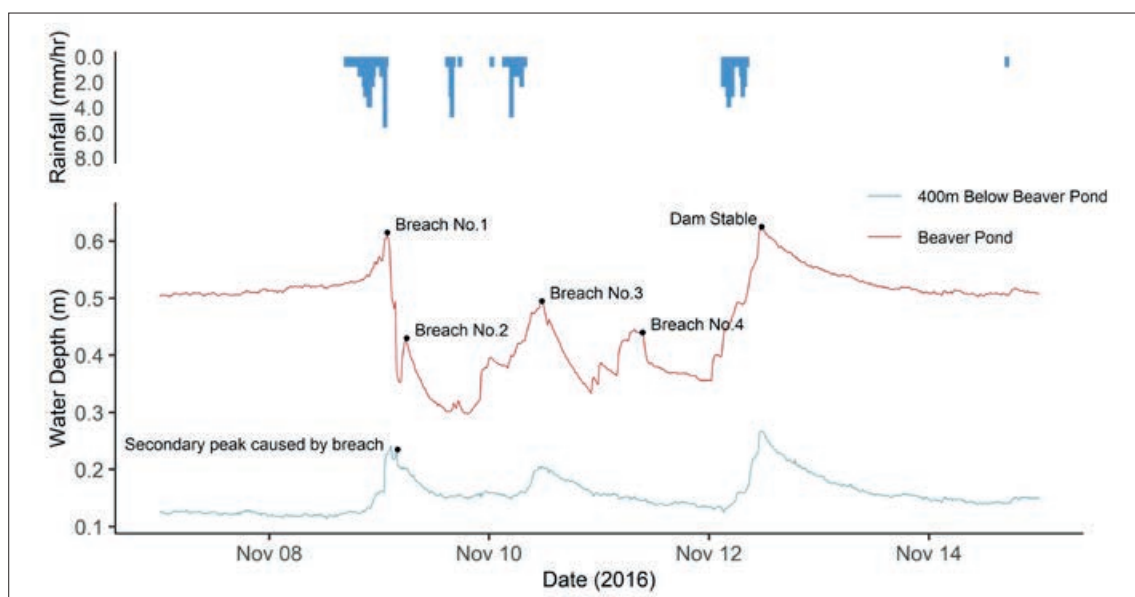
← **Figure 3.3**
Watercourse hydrograph immediately upstream of beaver dam (red) and 400m downstream (blue) during a partial breach of the dam during a high flow event in November 2016. During the high flow event that caused the breach, there is a lower secondary peak observed downstream which is likely to be the result of the dam failure. It is also possible to see how the beaver dam collapsed and was rebuilt several times before it re-stabilised.

Damage to dams of varying magnitudes has been observed during high energy winter storm events (Figure 3.3). This damage is typically more severe on larger streams which experience higher stream power. In dam sequences, the impact on downstream flow regimes is mitigated/negated by the overall combined impact of the dam sequence (often associated with dense riparian vegetation) rarely producing discernible downstream flood pulses. Damage typically manifests itself as partial breaches in dams. These breaches are commonly repaired by beavers overnight.

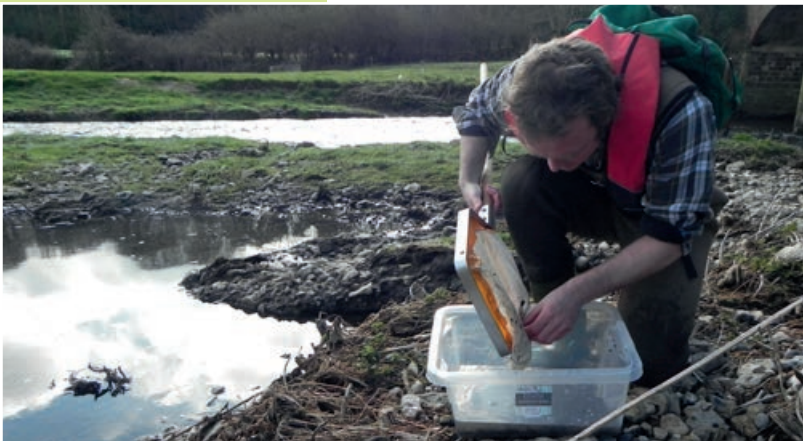
↓ To complement the aquatic invertebrate sampling carried out by the EA, additional samples have been collected from routine EA monitoring sites, using comparable techniques. This information will contribute to current understanding of the impacts of beaver dams on macro-invertebrate communities as they evolve.

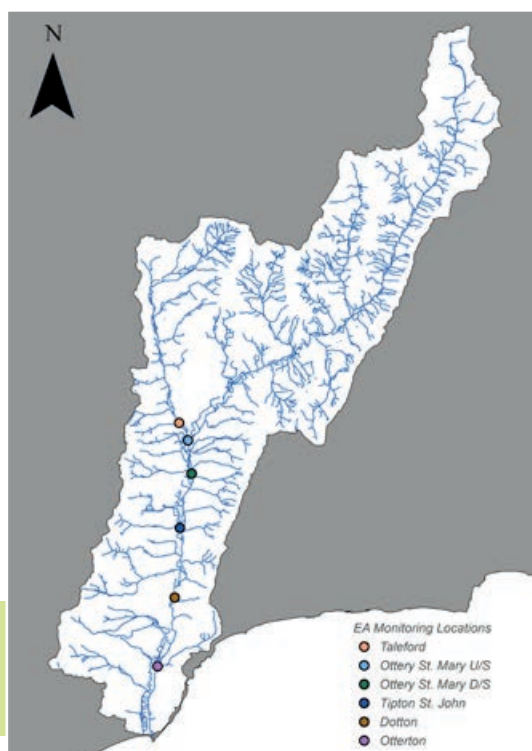
→ **Figure 3.5** Locations and description of EA invertebrate sampling locations.
