BRIMSTONE
SITE INVESTIGATION

DETAILED
UXO RISK ASSESSMENT

STAGE 2 DETAILED UXO RISK ASSESSMENT

Client: University of Exeter
Project Ref: UOEX02R
Site: University of Exeter
Report Ref: DRA-21-1255-01-UOEX02R-UniversityOfExeter
Revision: 1
Status: Final
Release Date: 16th July 2021

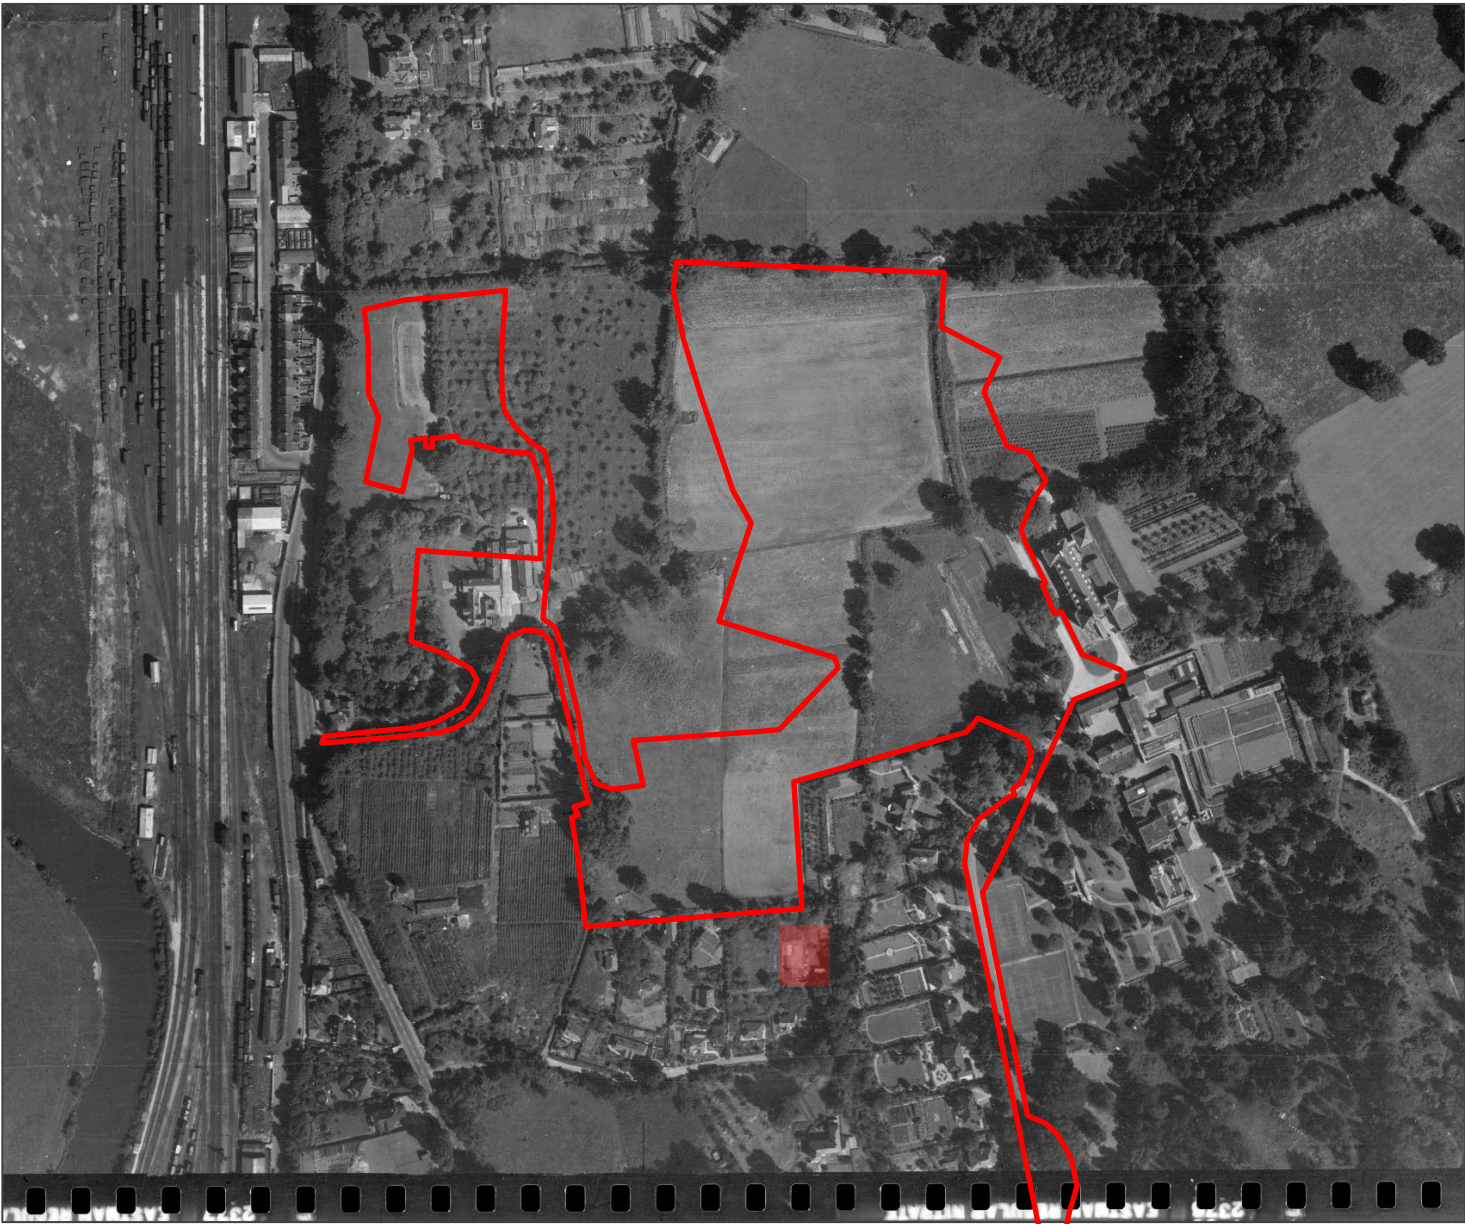
Period	Photo Date	Review
Post-WWII	1947	FIGURE 5.1: This vertical view photograph was taken approximately two years after the end of WWII (in Europe). The undeveloped areas of the Site appear to be well maintained, with no obvious evidence of bomb damage occurring i.e. cratering, disturbed ground. The structure partially encompassed by the Site's western border appears to have survived externally structurally intact. The tennis courts present in post-WWII OS mapping can be seen in the east and west of the Site. A small area of structural clearance can be seen to the immediate south.

Structural clearance

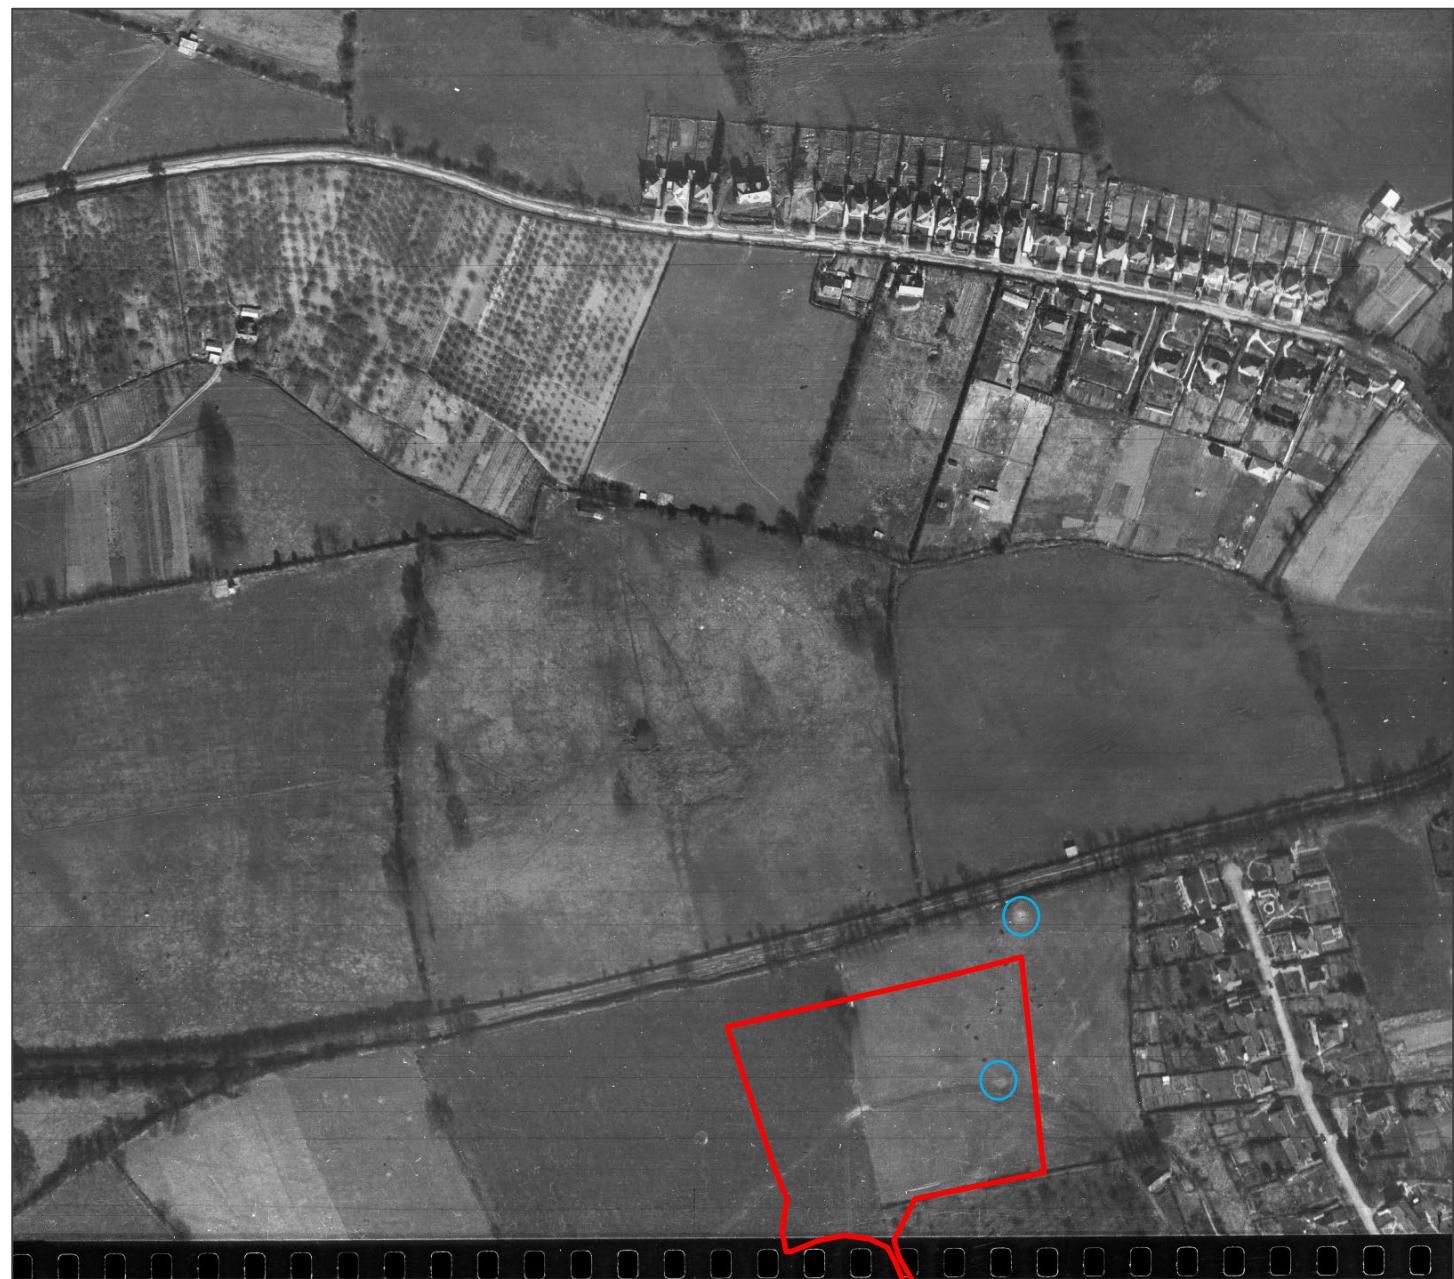
Period	Photo Date	Review
Post-WWII	1947	FIGURE 5.2: This vertical view photograph was taken approximately two years after the end of WWII (in Europe). The southern extent of the Site is not visible in the photograph. The pathway identified in OS mapping can be seen intersecting the Site. A small herd of livestock can be seen in the north-east, suggesting that the Site was of an agricultural nature. A circular depression is noted in the east of the Site. A further depression is noted to the north-east. These represent potential craters. The residential properties to the east appear to have survived WWII externally structurally intact.

Potential bomb crater

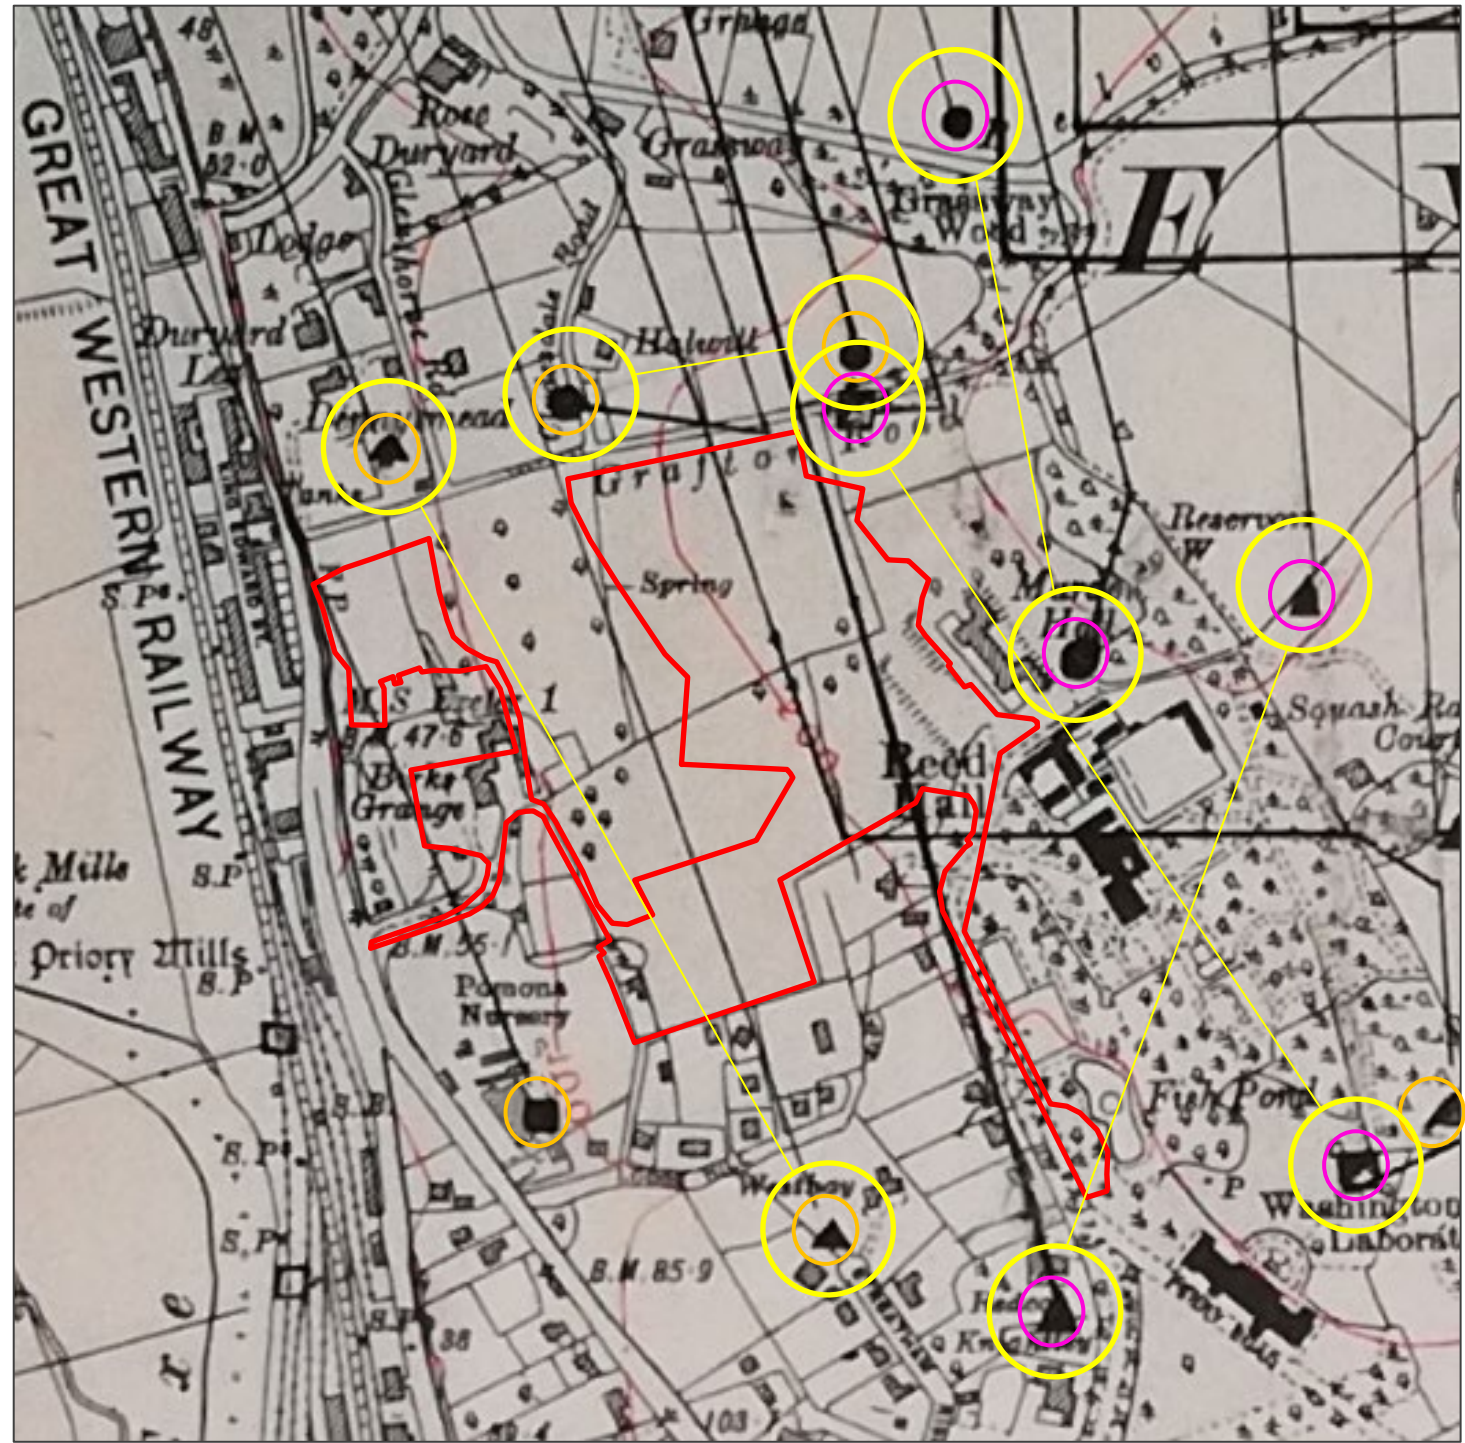
- 50kg HE bomb
- ▲ 250kg HE bomb
- 500kg HE bomb
- * Unclassified HE bomb

○ Potential bomb-stick

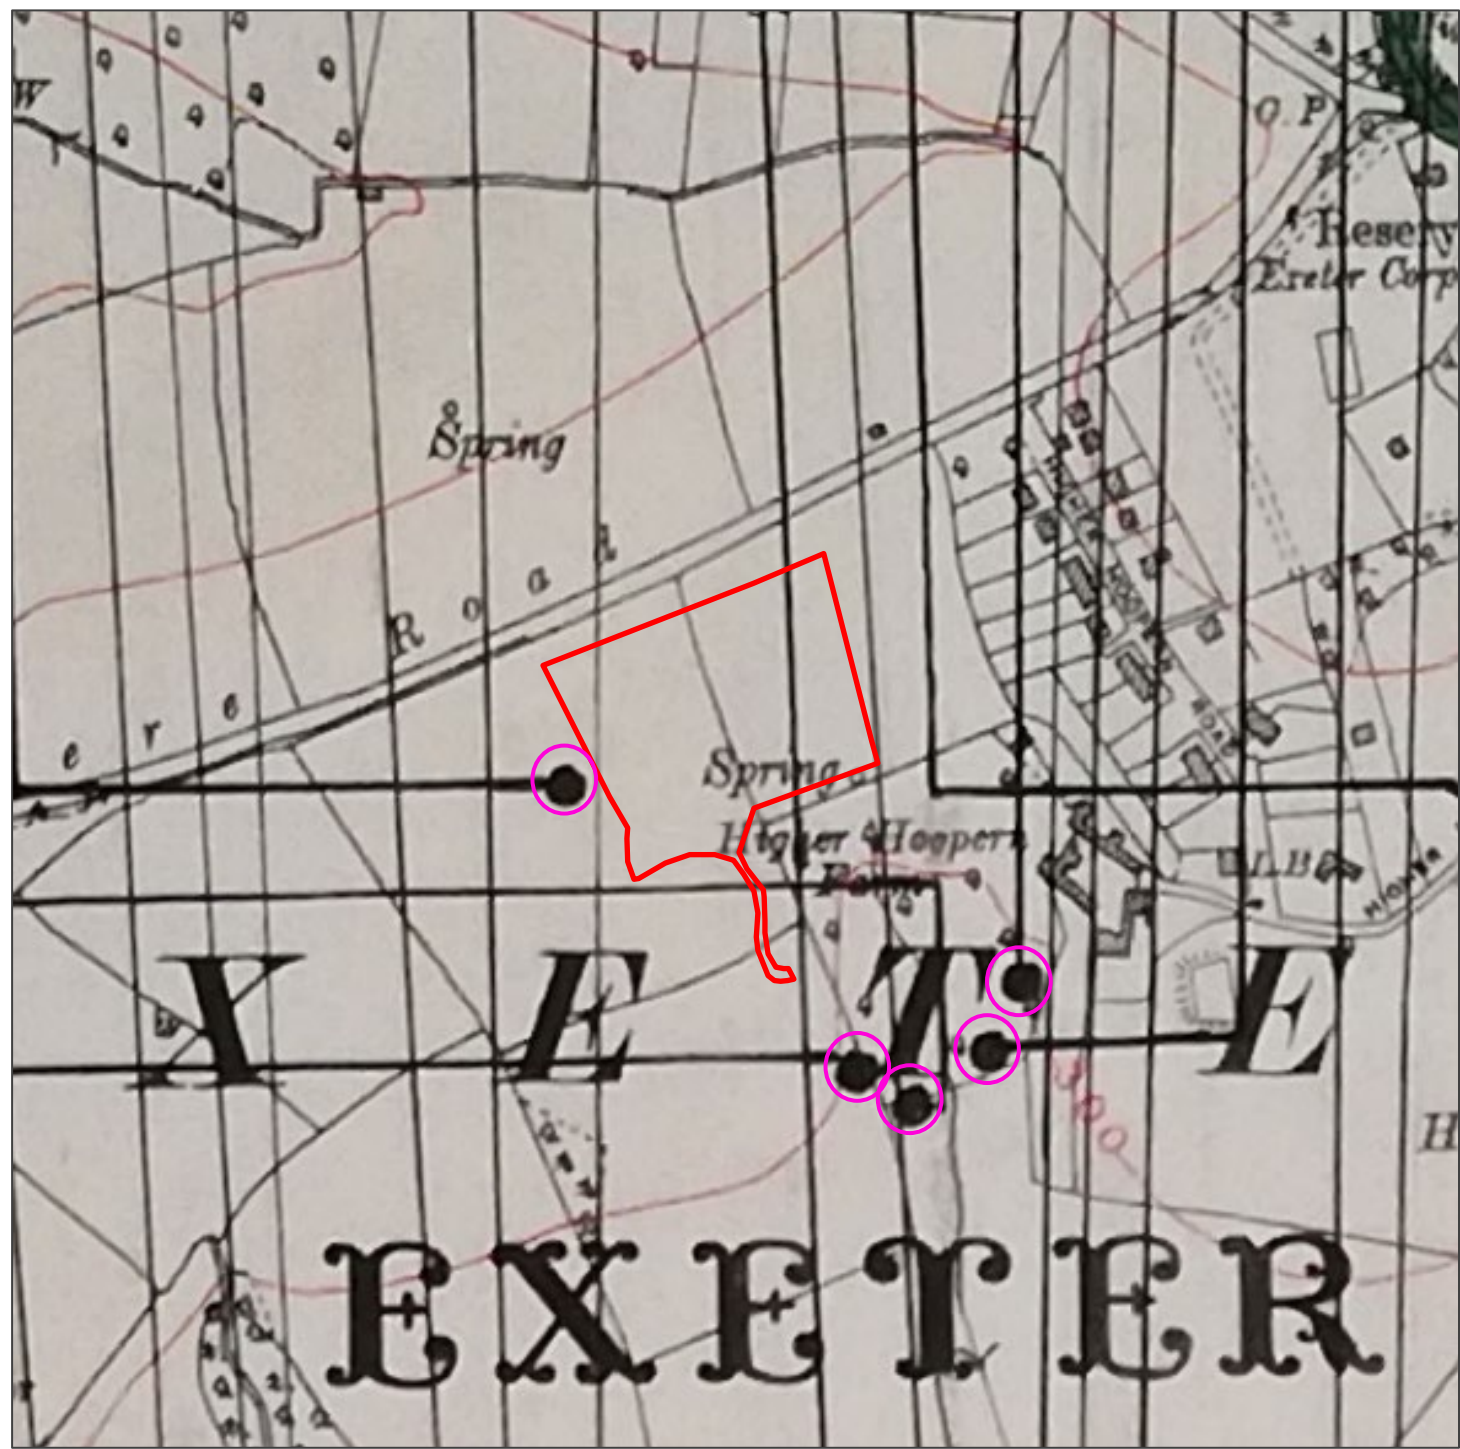
- 50kg HE bomb
- ▲ 250kg HE bomb
- ◼ 500kg HE bomb
- * Unclassified HE bomb

EXETER	
DATE OF RAID	Nº
23/24 ~ 4 ~ 42	1
24/25 ~ 4 ~ 42	2
25/26 ~ 4 ~ 42	3
3/4 ~ 5 ~ 42	4
30 ~ 12 ~ 42	5

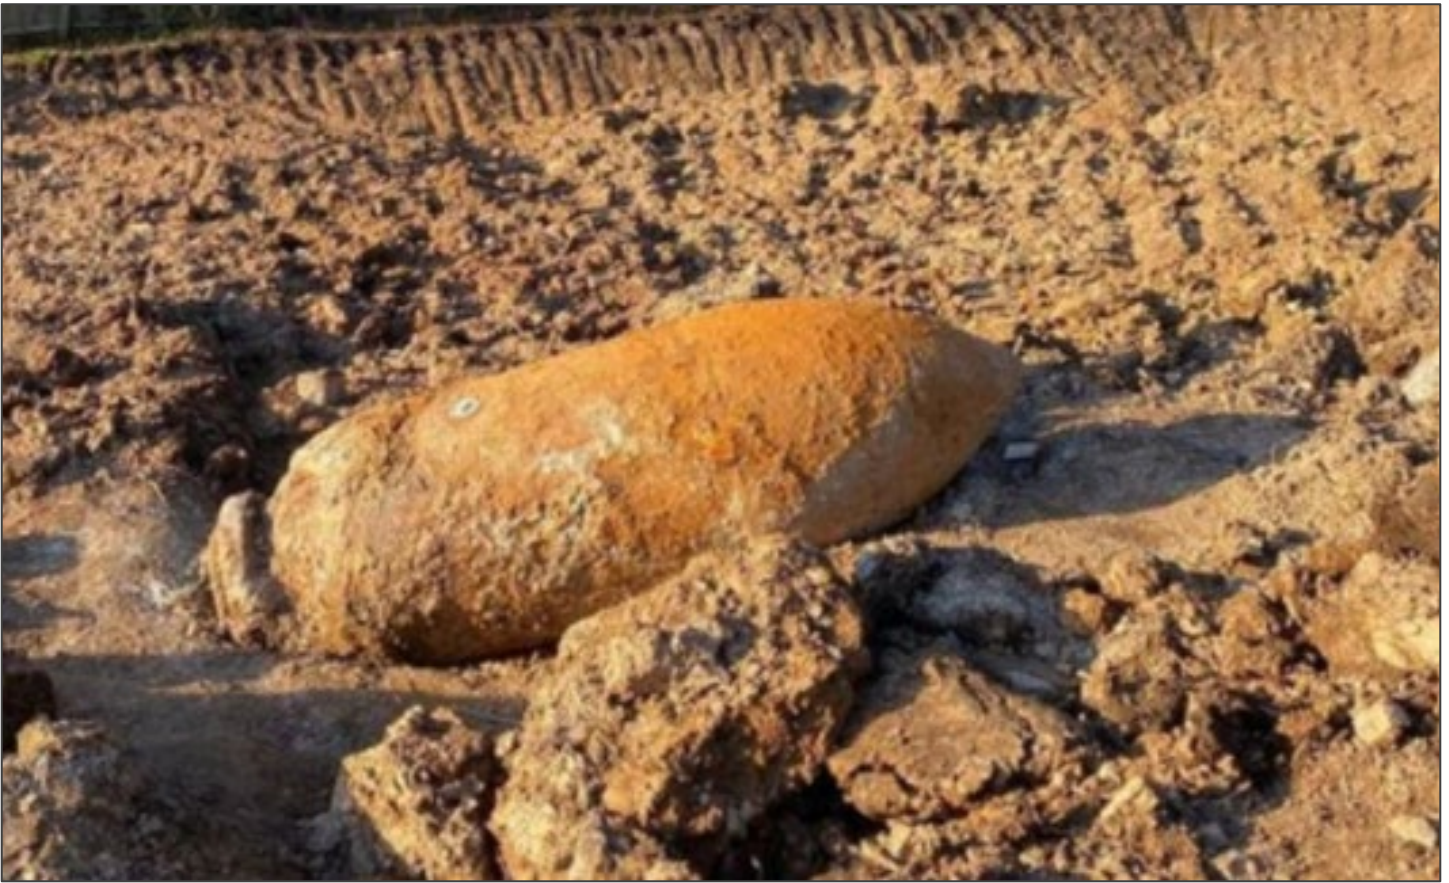
Above: item of unexploded ordnance uncovered during development works immediately north of University of Exeter campus.

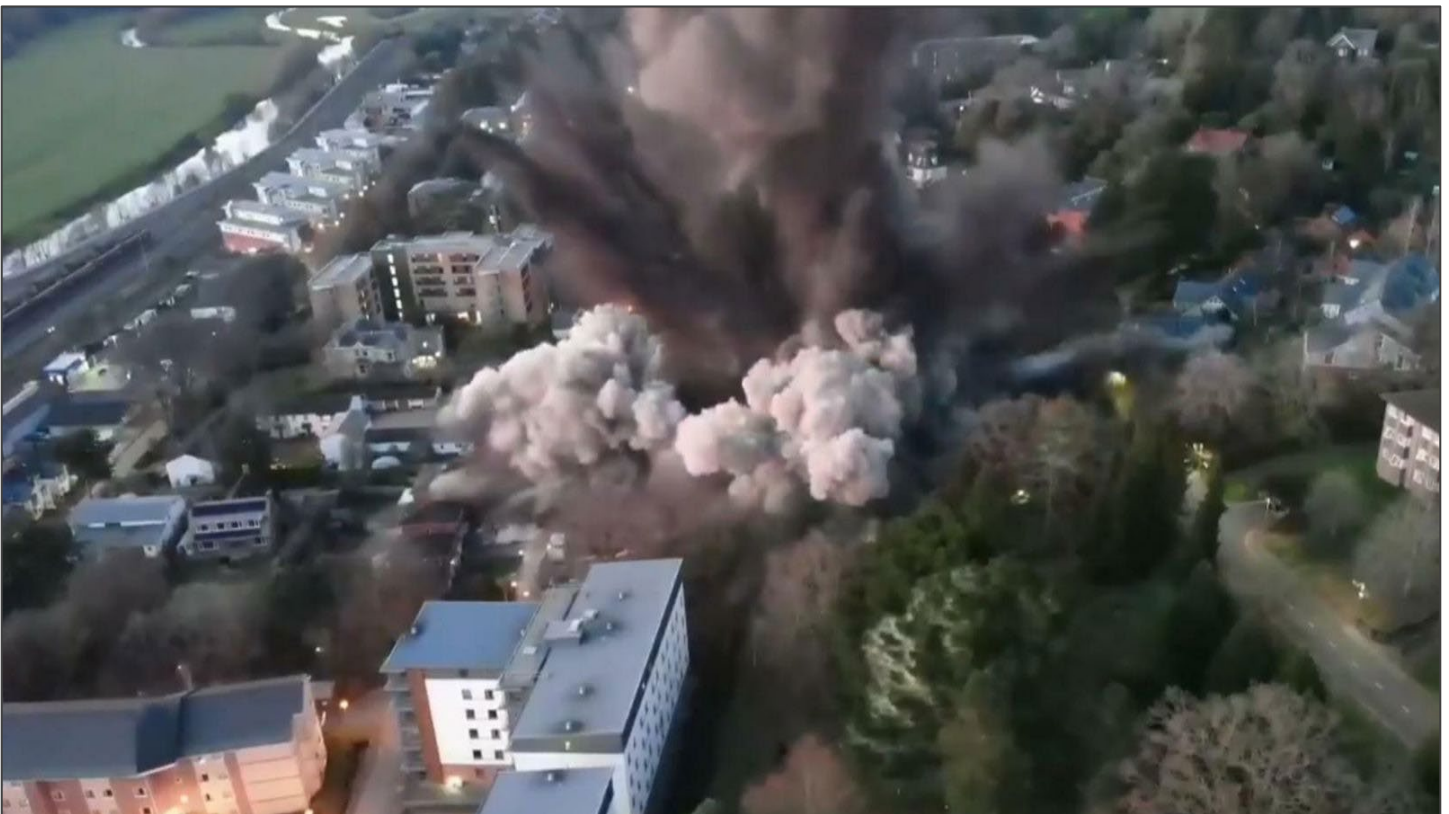
Above: detonation of item of unexploded ordnance.

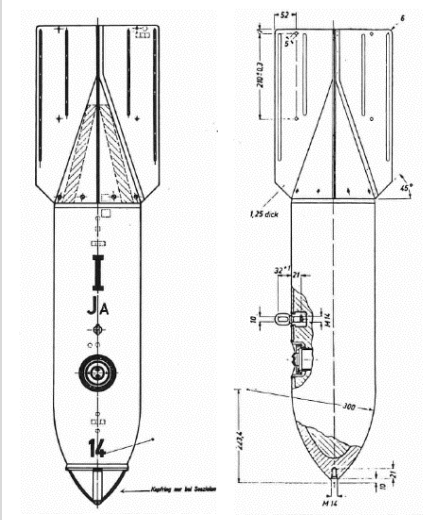
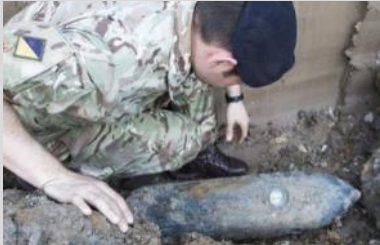
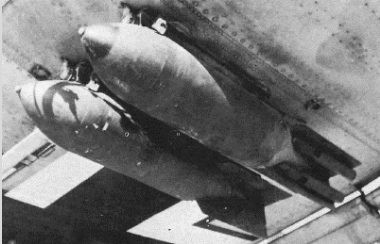
SC 250

Bomb body and tail painted grey/green with a yellow stripe on the tail unit. Steel construction.

8 x variants. Additional fittings: Kopfring nose for limited penetration and Stabbo nose for dive-bombing.

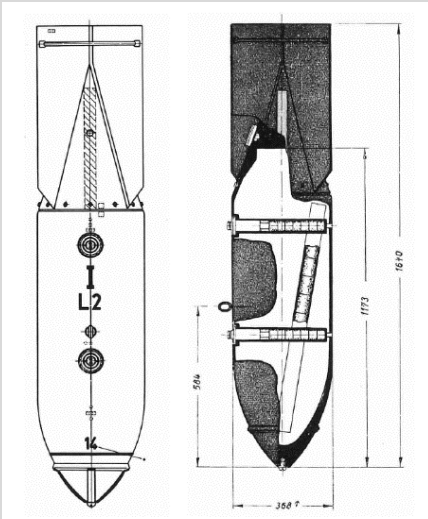
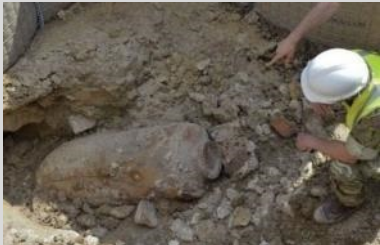
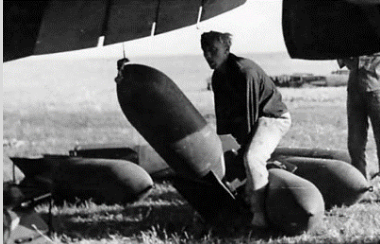
SC 500

Bomb body and tail painted grey/green with a yellow stripe on the tail unit. Steel construction.

8 x variants. Kopfring nose for limited penetration. Stabbo nose for dive-bombing.

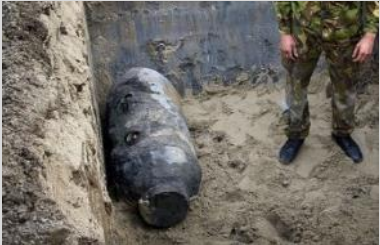
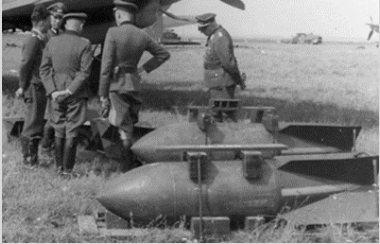
Bomb body and tail painted grey/green or buff with a yellow stripe on the tail unit. Steel construction.

3 x variants. Kopfring nose for limited penetration.

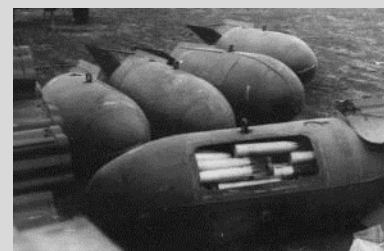
**Brand C50**

Bomb Weight: 41kg (90.4lb)
Incendiary Weight: 13kg (30lb)
Filling: Main fill (86% Benzine, 10% Rubber) plus 4% Phosphorus in glass bottles
Fuse Type: 1 x electrical impact fuse
Bomb Dimensions: 762mm length x 203mm diameter
Appearance: bomb body and tail painted grey or green with the rear of the bomb painted red and a red band around the centre of the body.
Variants: C 50 B: 77% White Phos fill
 C 250 A: 87.7% Petroleum, 11.7% Polystyrene, 0.5% White Phos (185kg version)

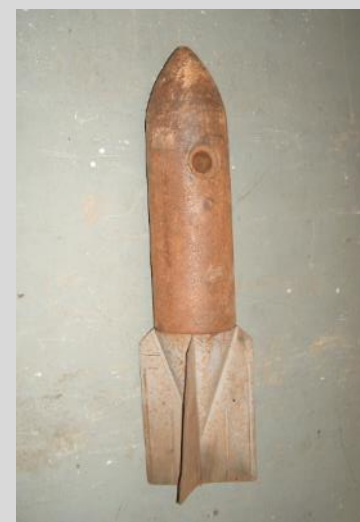
**Spreng-Brand C50 - Fire Pot**

Bomb Weight: 34kg (75lb)
Explosive Weight: 9kg (20lb)
Filling: TNT burster charge, 6 x Thermite containers (fire pots) and 67 x small triangular incendiary elements.
Fuse Type: 1 x electrical impact fuses or aerial burst fuse
Bomb Dimensions: 711mm length x 203mm diameter
Appearance: Bomb body and tail painted grey/green or pale blue with red base plug and red or green incendiary markings. Steel construction.
Operation: A charge blows off the base plate, firing a plume of incendiary mixture 100 yds. Approx 1 second later the HE charge detonates.

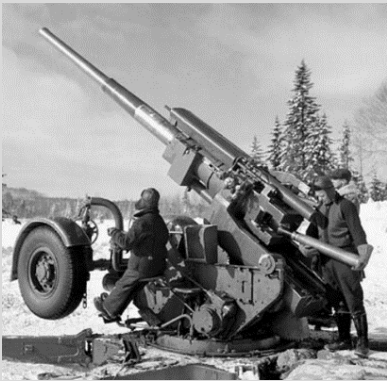
LAA Battery - 40mm Bofors Shell

Shell Weight: 0.84kg

Ceiling: 7,000m

Variants: HE or AP shells. Both with rear tracer compartment

The 40mm Bofors gun could fire 120 x HE shells / minute to a ceiling of 1,800m. Each shell was designed to self-destruct if it didn't strike an aircraft, however, inevitably some failed and fell back to earth.
